# Santa Monica Beach Restoration Pilot Project

Year 2 Annual Report

August 2018

**Prepared by: The Bay Foundation**

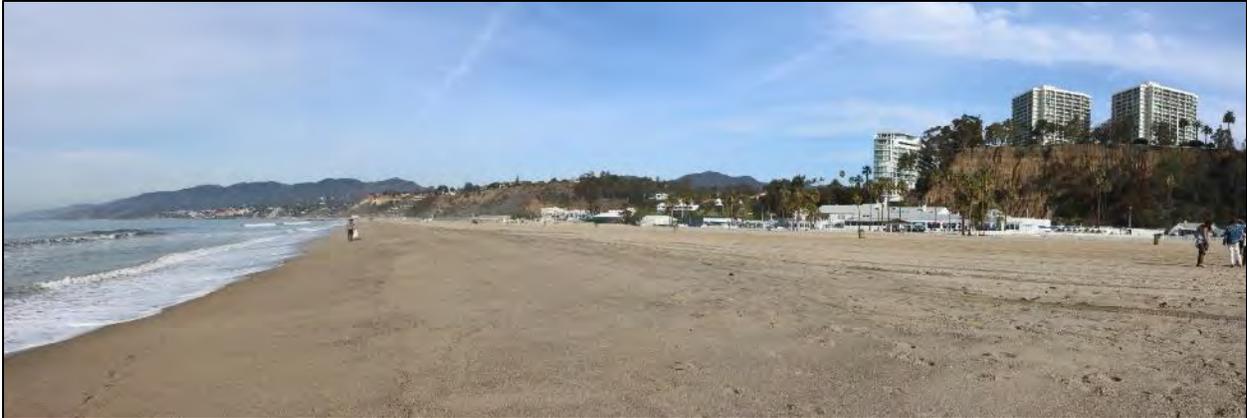
Figure 2. Photograph of the project site prior to restoration at Santa Monica Beach, Santa Monica, CA.

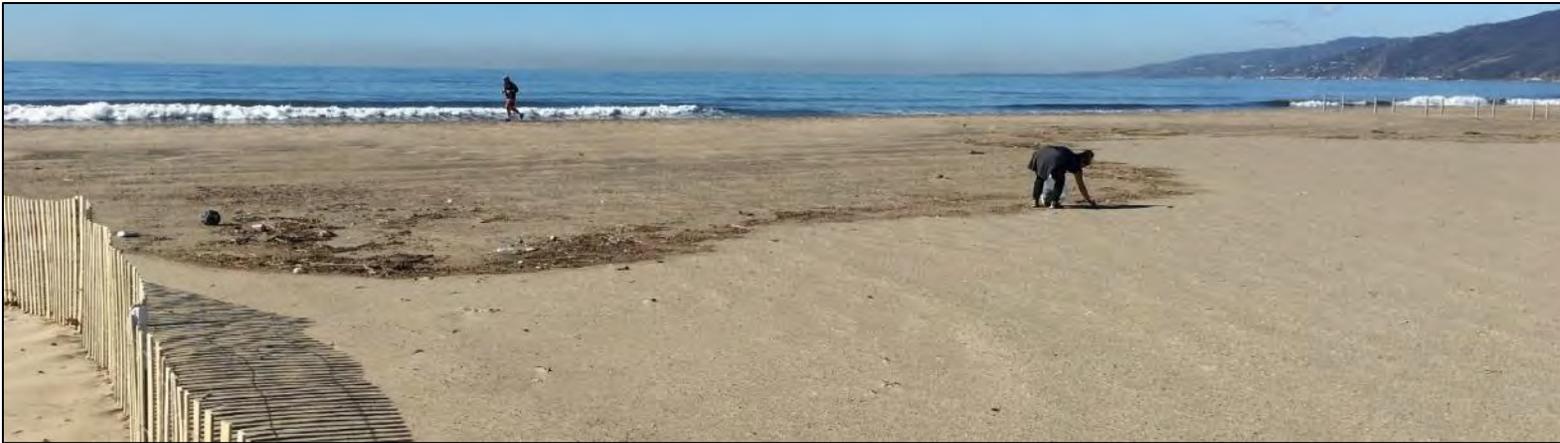
Figure 5. Photograph of post-restoration project site (25 January 2017).

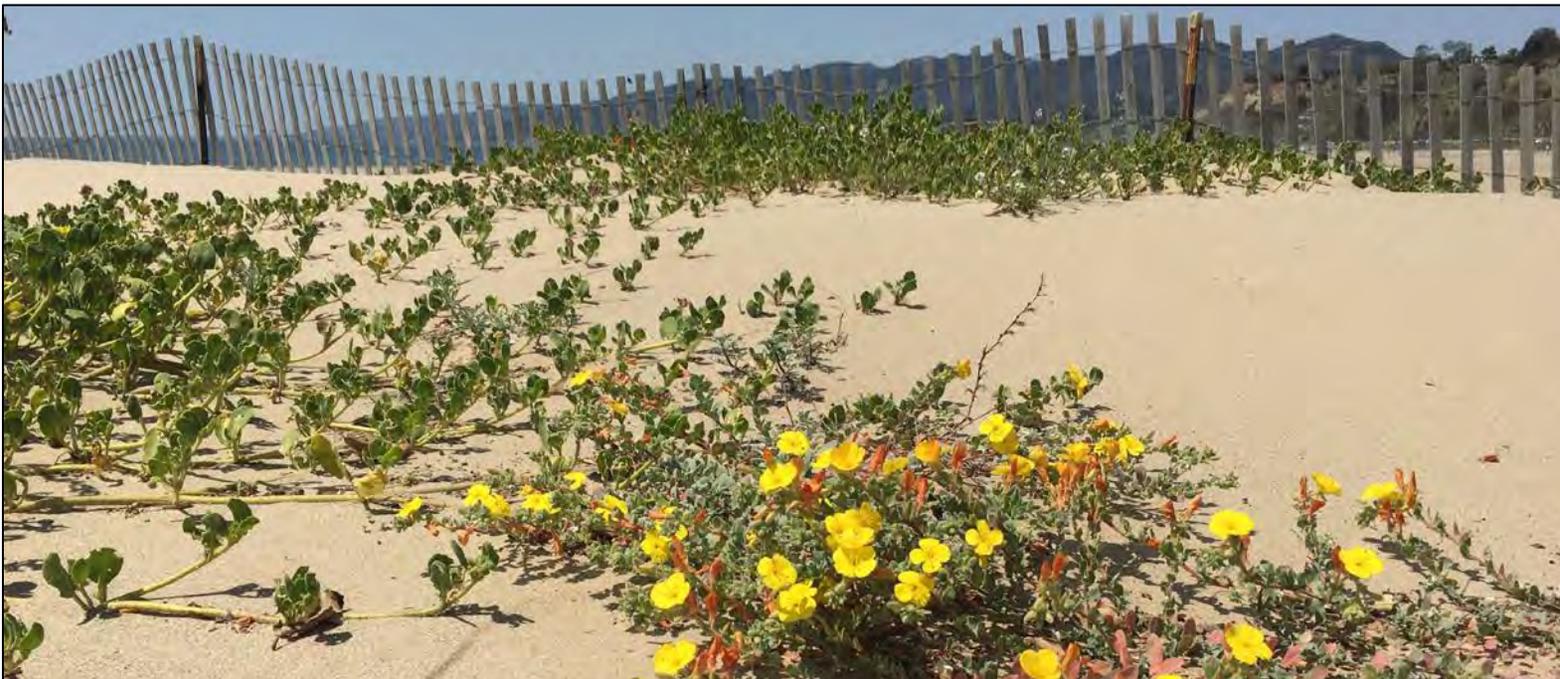
Figure 6. Photograph of post-restoration project site (13 April 2018).

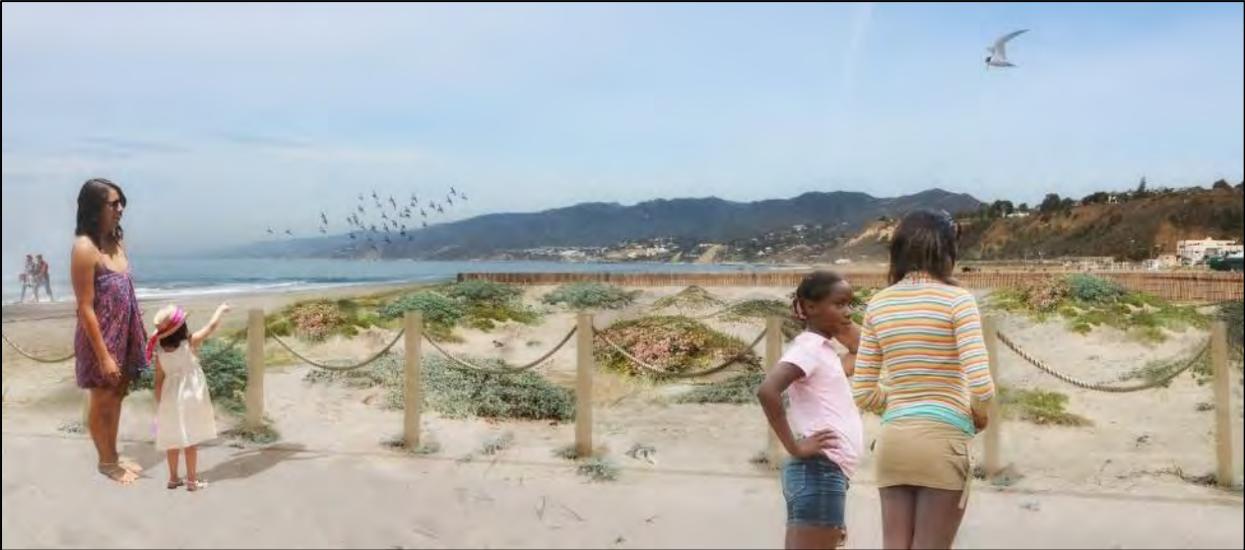
Figure 9. Artistic rendering of project site several years in the future by Mia Lehrer and Associates.

Possibly the most significant outreach occurred through the development of a website that highlighted artistic renderings of the project completed by Mia Lehrer and Associates (Figure 9), photographs, and project information and materials. The project website and frequently asked questions can be found here: <http://www.santamonica.org/explore/beaches-dunes-bluffs/beach-restoration/santa-monica-beach-restoration-pilot/>. Selected media links are presented below the outreach photographs. The site is frequently written up in local newspapers, blogs, newsletters, and social media postings.

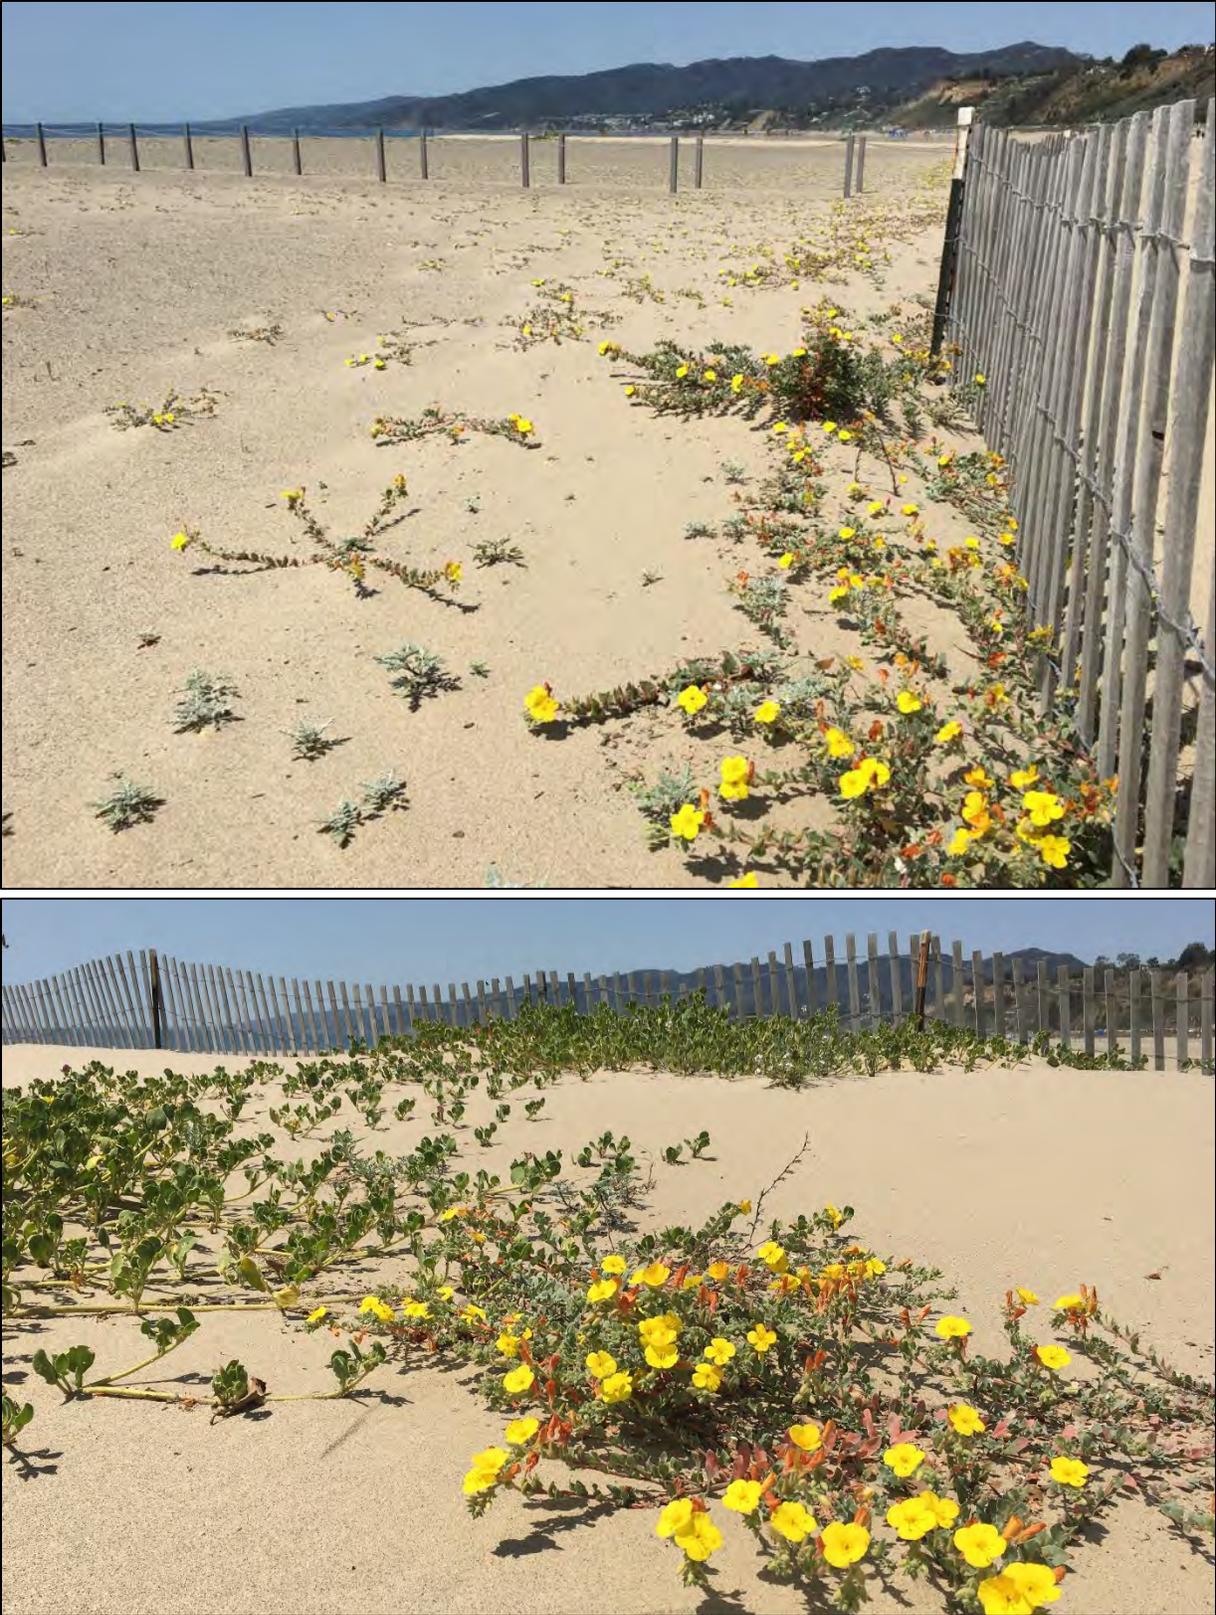
Figure 18. Photograph of various native vegetation facing the northern fence line (top) and along the northern fence line (13 April 2018).

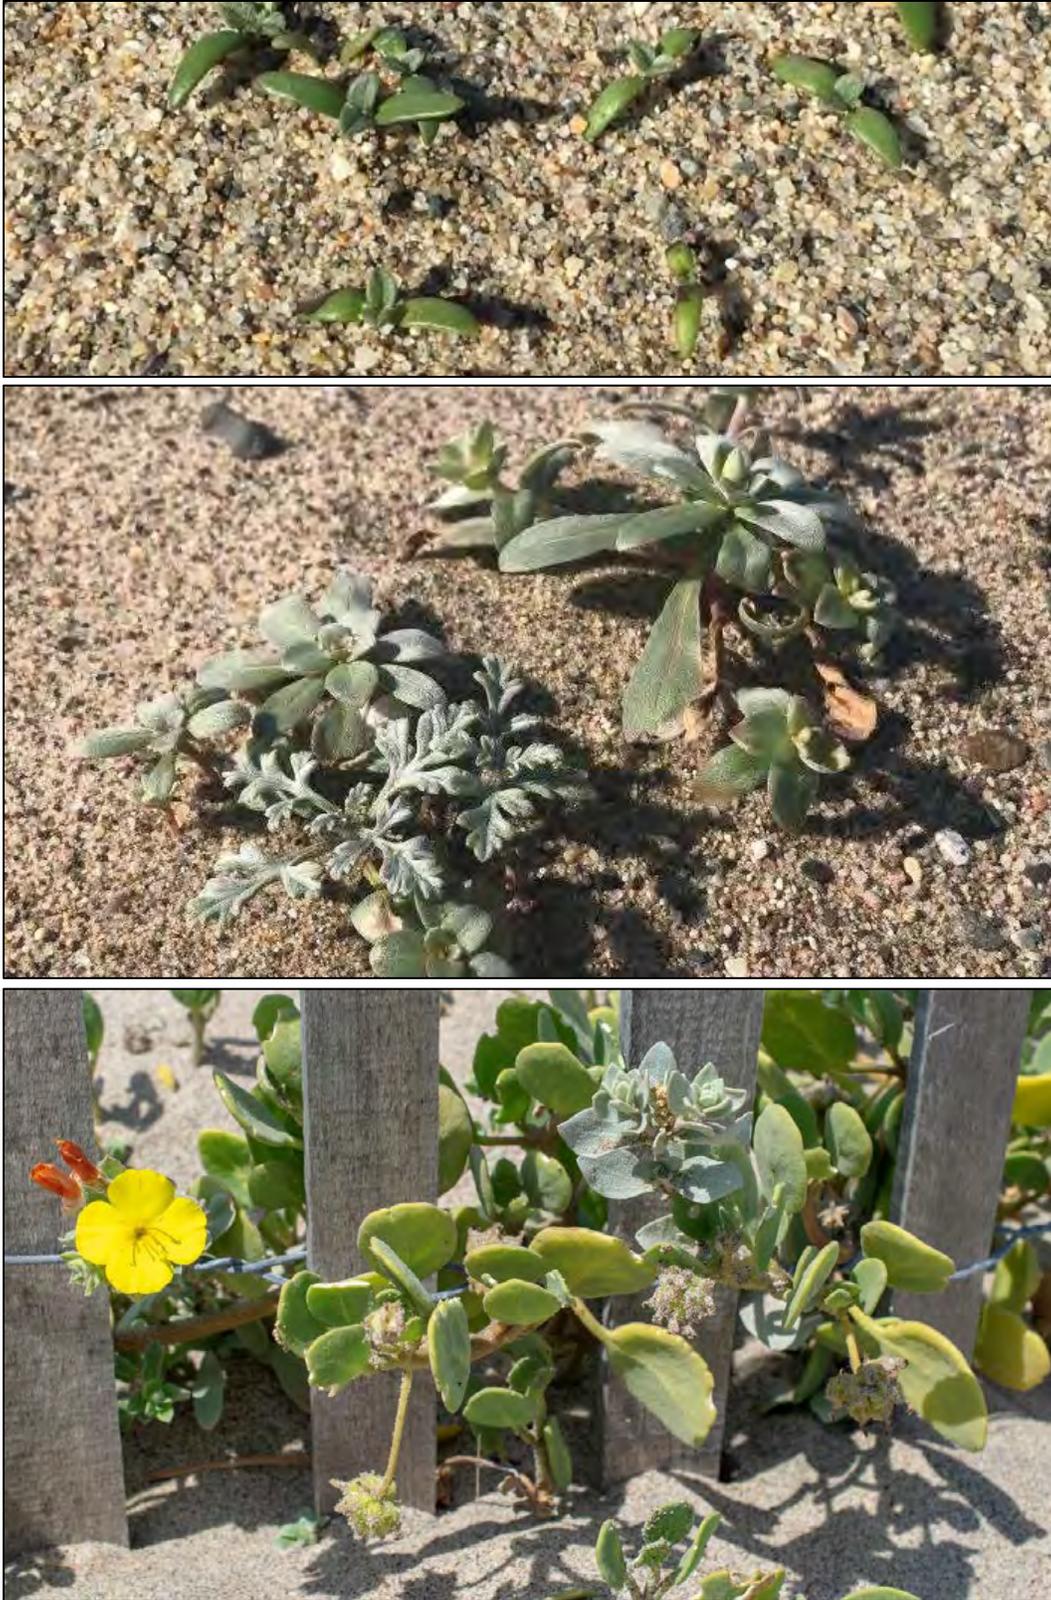
Figure 19. Photographic series of various seedling species over time (top: January 2017, middle: April 2017, bottom: May 2018).

Both the baseline survey and each of the control surveys found zero seedlings on all transects. By the time of the June 2017 surveys, seedlings were identified much more prominently as vegetation cover, thus, instead of “seedling counts”, flowering species were identified. Table 2 displays the results of the seedling counts from the 24 March 2017 and 11 January 2018 surveys and extrapolates the results up to the total project area (approximately 6,900 m<sup>2</sup>) by species. Note that the extrapolated data are based on averages and are thus not likely to represent an exact numerical count for the area but are considered estimates (rounded down to the closest thousand). The March 2017 survey found more seedlings within the restoration area than the January 2018 survey, since it closely followed the initial vegetation seeding in December 2016. The January 2018 vegetation data are better represented as flowering plants. The total estimated number of seedlings in March across the entire project area was 158,000, weighted heavily by beach bur sage as the most frequently identified germinated seedling (Table 2). Woolly head seedlings and beach sand verbena (*A. umbellata*) were not found within the surveyed quadrats and are thus underrepresented as zero data points, though present on site within the restoration area. Figure 19 represents a photo series over time of a variety of vegetation species. The presence of germinated seedlings in 2018 (second year) indicates the presence of a viable seed bank still within the restoration project area.

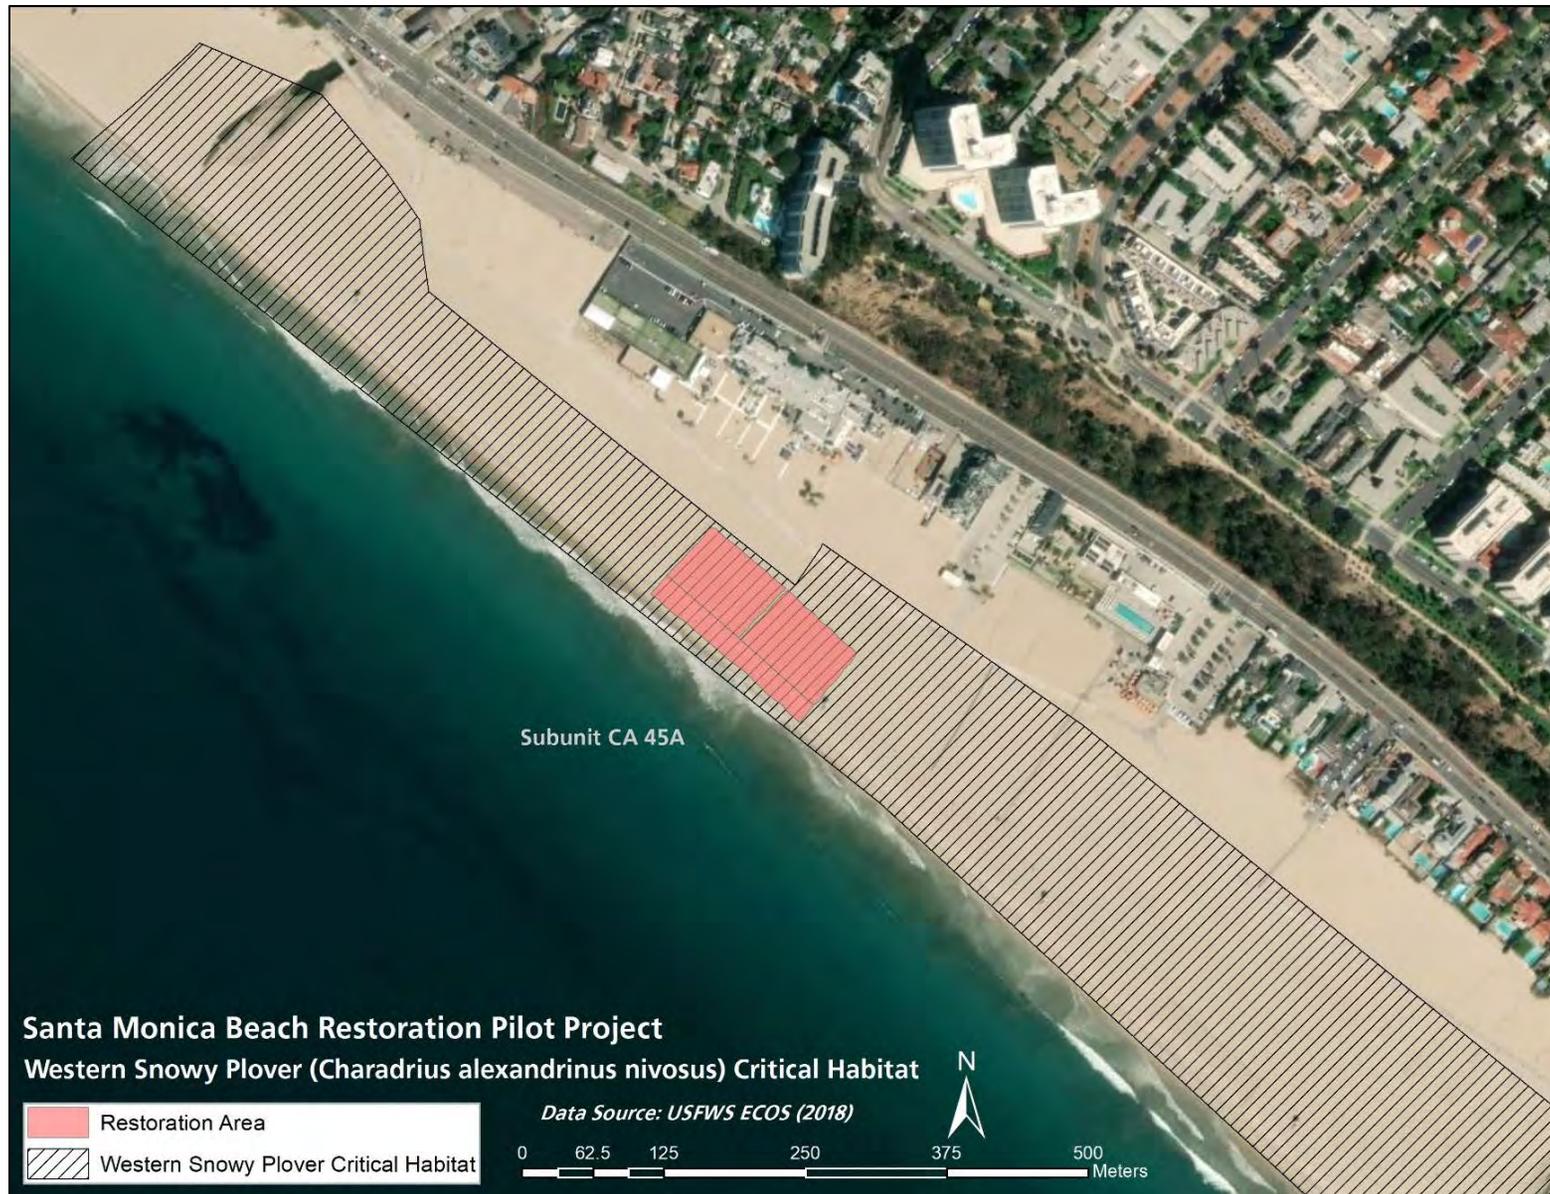
Figure 25. Map of WSP critical habitat (Subunit CA 45A) and restoration area boundary (Data source: USFWS ECOS 2018).

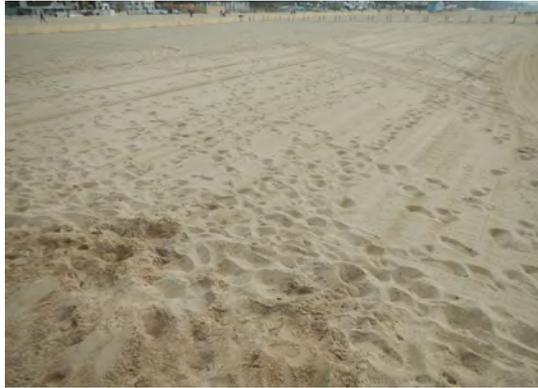
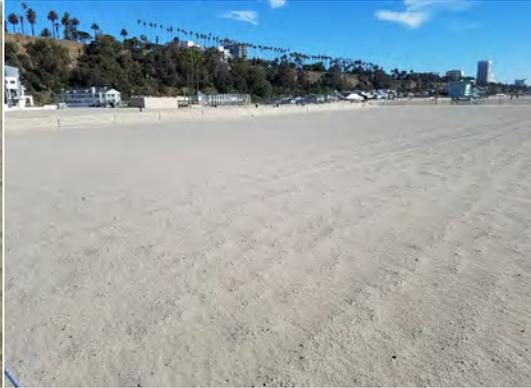
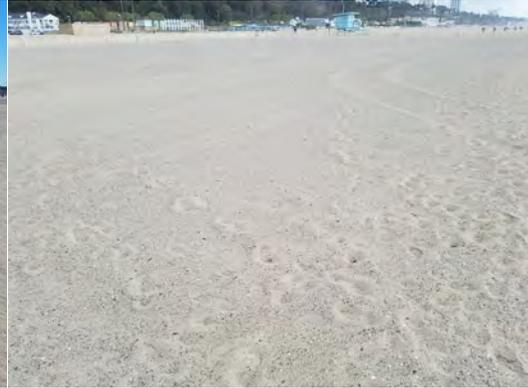
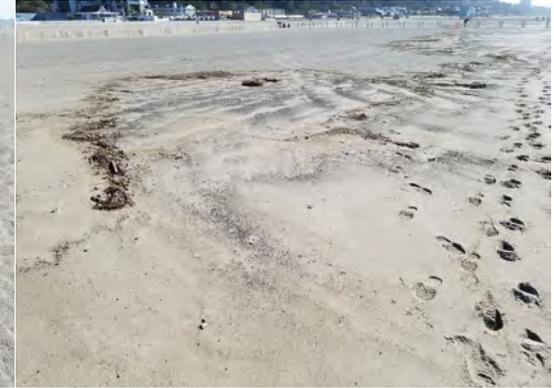
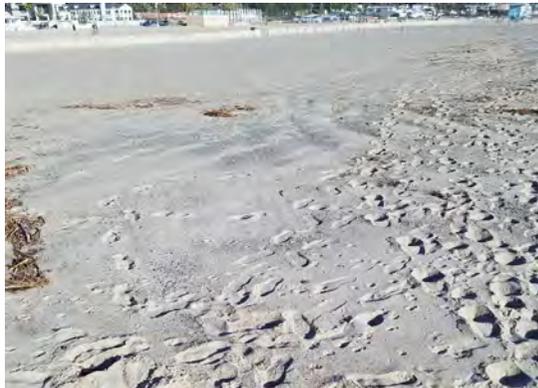
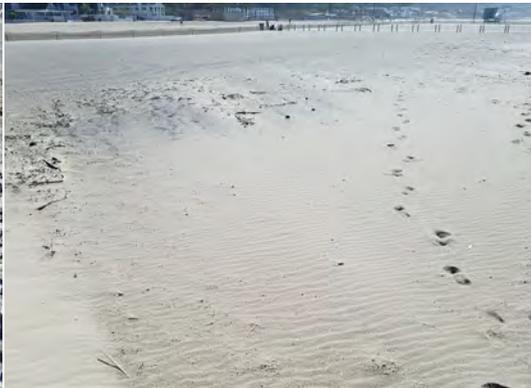
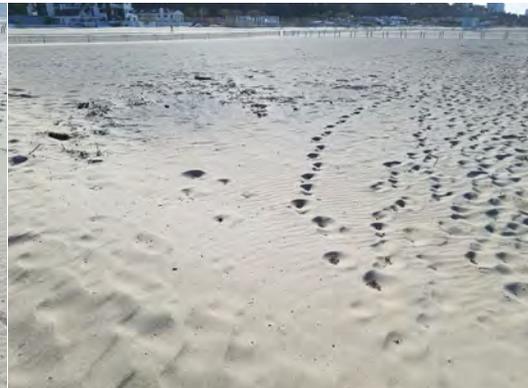
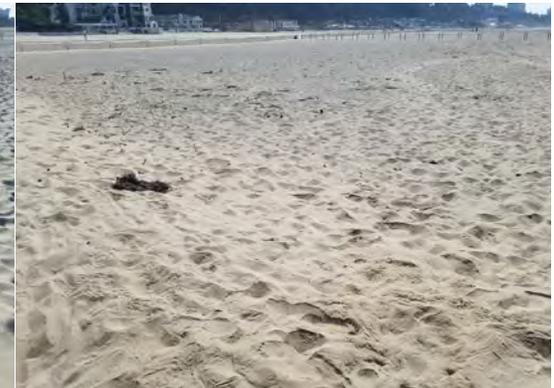
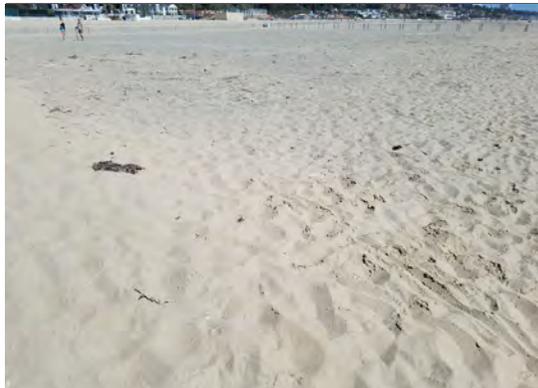
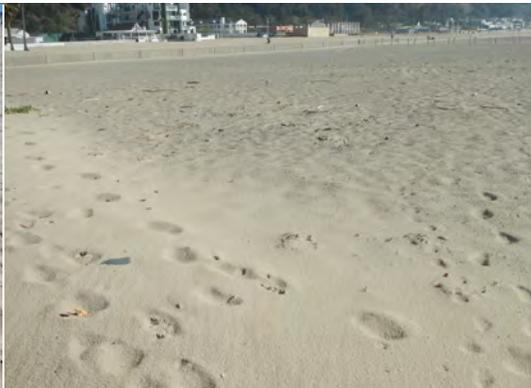
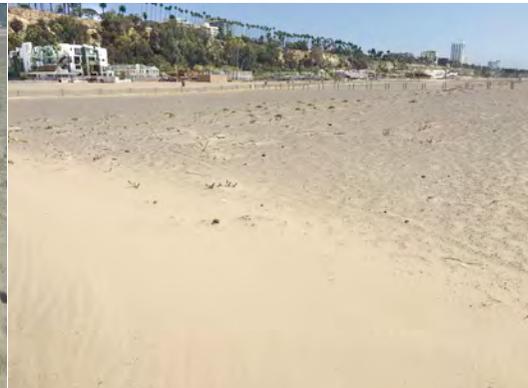
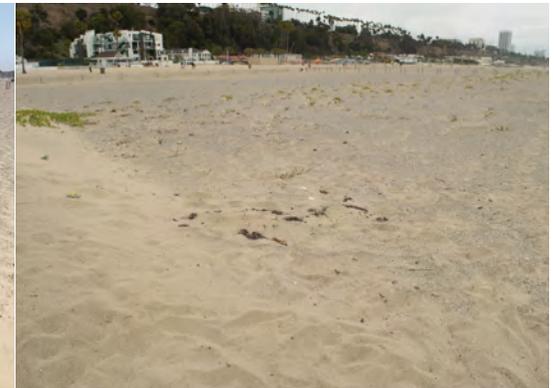
Photo Point 1A

Figure 47. Photo Point Series (bearing 88°)

Photo point monitoring helps to identify seasonal site changes and project-level changes as a result of the restoration activities (e.g. native vegetation growth, plant hummock formation). Survey methods are described in detail in [SOP 7.2 Level 2 Photo Point](#) (TBF 2015a). Photographs can be used as qualitative assessments of broad-scale changes following restoration activities and plant hummock development over time. Seventeen photographs were taken at nine stations on eight survey days. Two locations were chosen to present in this report as the best representative photographs taken on 13 and 17 December 2016; 13 and 25 January, 4 February, 24 March, 25 April, 21 August, and 13 September 2017; 11 January, 13 April, and 24 May 2018 (Figures 47 and 48). While the vegetation cover is still difficult to see within the restoration area, small individual plants are visible starting in the spring months, with a notable increase in plants seen along the fence lines in the 24 May 2018 survey. Also notable are the changes in sand grain size over time, visible footprints indicating use of the site, and the changes in sand deposition towards the fence lines on three sides of the restoration area (ocean ward side is not fenced to allow for movement in and out of the restoration area).

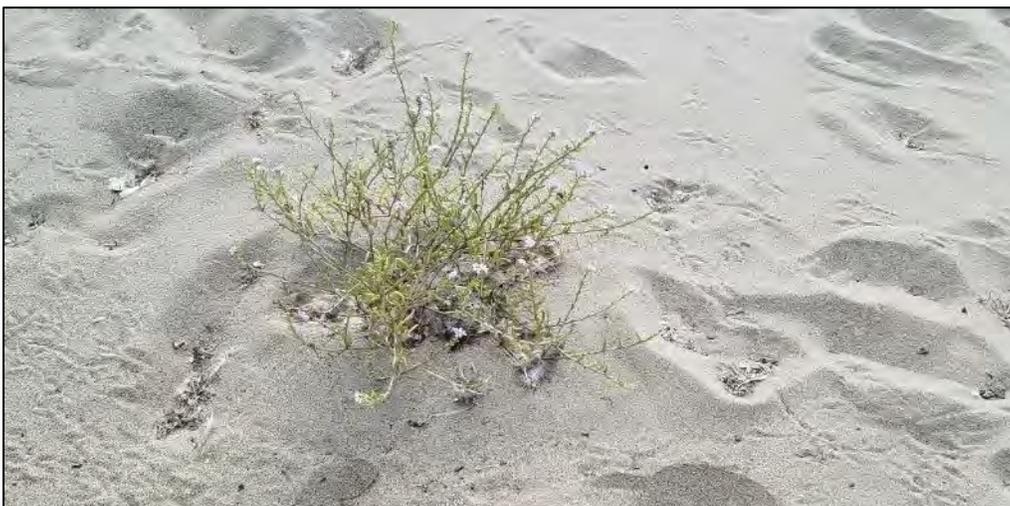
Thus far, one non-native species, sea rocket, has invaded the project area to a very minimal extent. The areas where it is present do not appear to be directly negatively affecting the native vegetation; however, it continues to be thoroughly monitored and removed periodically from within the restoration area. It is likely to continue sprouting, at least until the native vegetation becomes fully established, because there are source seed populations along the bike path and back dune areas adjacent to the project site, and an assumed pre-existing seed bank in the sand of the project area (Figure 49).

Figure 49. Non-native sea rocket within the project area (21 August 2017).

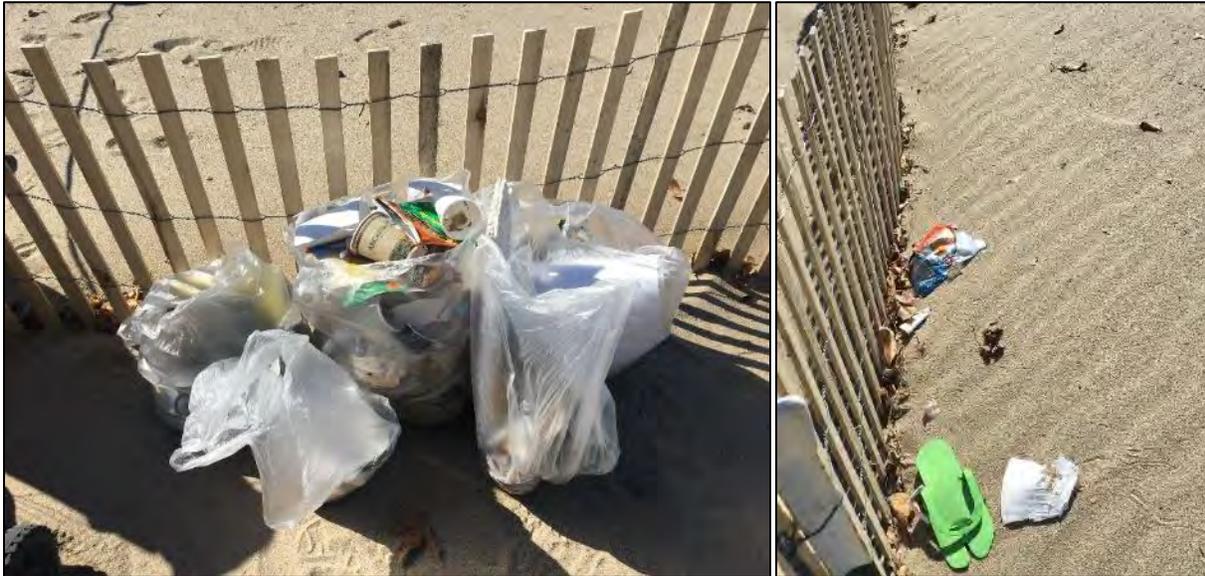
Trash continues to be very low within the restoration area. Interestingly, there is often more trash that is picked up in the sand immediately adjacent to the restoration plot, in beach areas that are frequently groomed. It is likely that the large grooming rakes either miss or bury some of the smaller tiny bits of plastic and polystyrene foam that are frequently found adjacent to and within the project area. Frequently seen trash items include cigarette butts, small bits of plastic, plastic straws, polystyrene foam, candy wrappers, and bits of coffee cups (Figure 50). Infrequently seen items include things like flip-flops, Frisbees, and tennis balls (Figure 50).

Figure 50. Trash collected after a storm event from within and adjacent to the project area (25 January 2017).
