Santa Monica Beach Restoration Pilot Project

Year 1 Annual Report

August 2017

Prepared by: The Bay Foundation

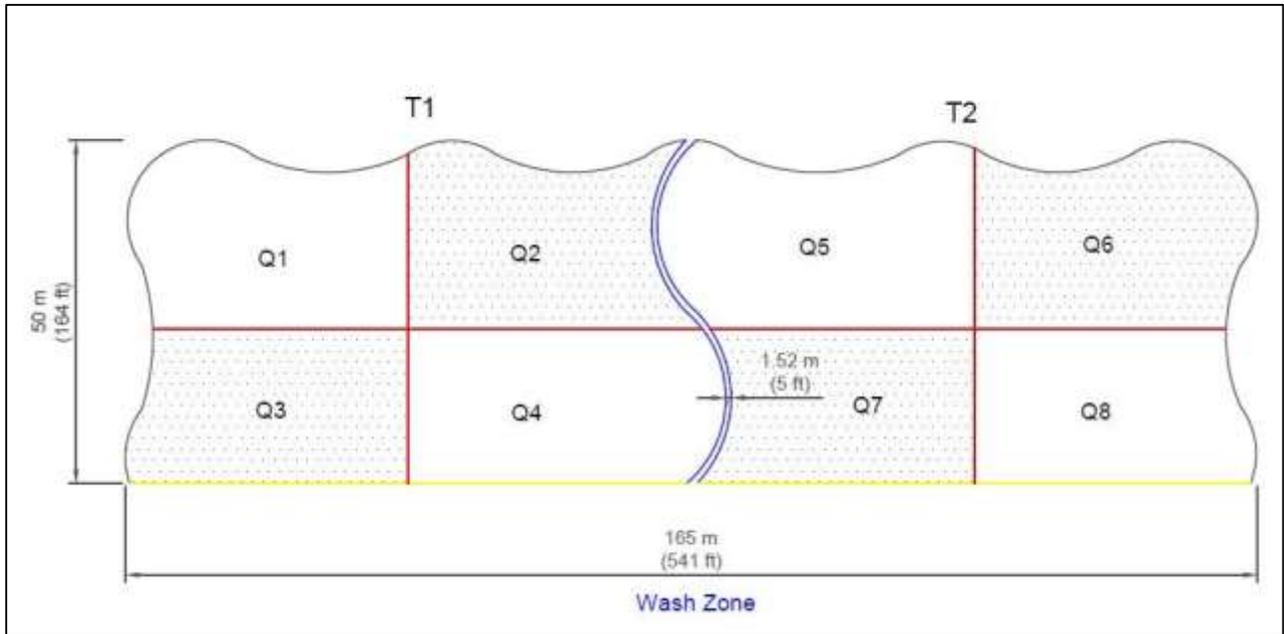
Figure 7. Restoration site graphic design, including two treatment plots (T1 and T2).

The project area is divided into two, roughly 1-acre, treatment plots (T1, or the North plot, and T2, or the South plot; Figure 7). The treatment plots are separated by a curved path, bordered by a symbolic rope fence. The exterior perimeter (except for the ocean-ward side) is surrounded by a low-lying sand fence (approximately 3 feet in height). Each treatment plot is further subdivided into four quadrants for analysis, though there are no physical barriers within the treatment plots. This subdivision allowed for an experimental treatment design by implementing two different seeding protocols.

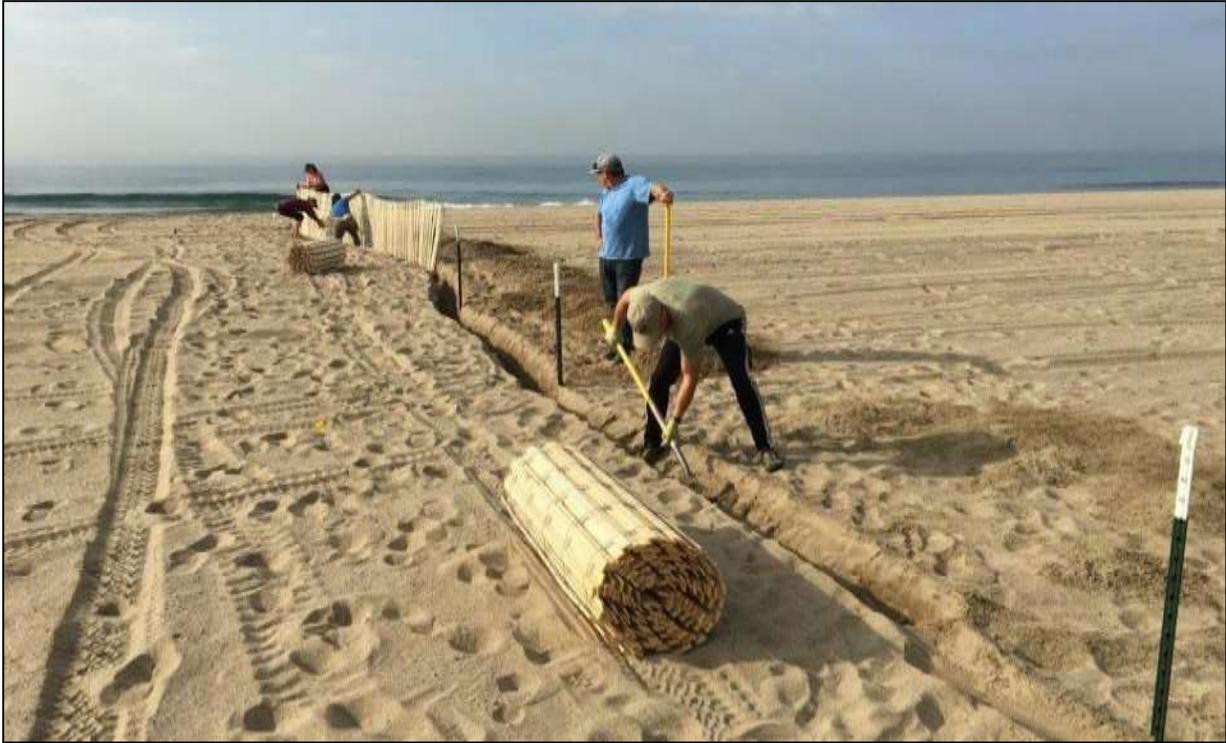
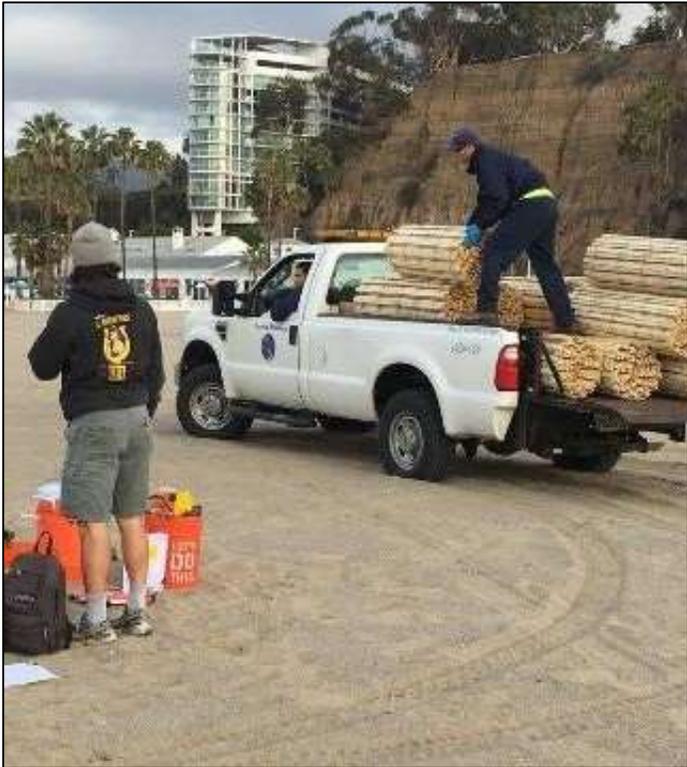
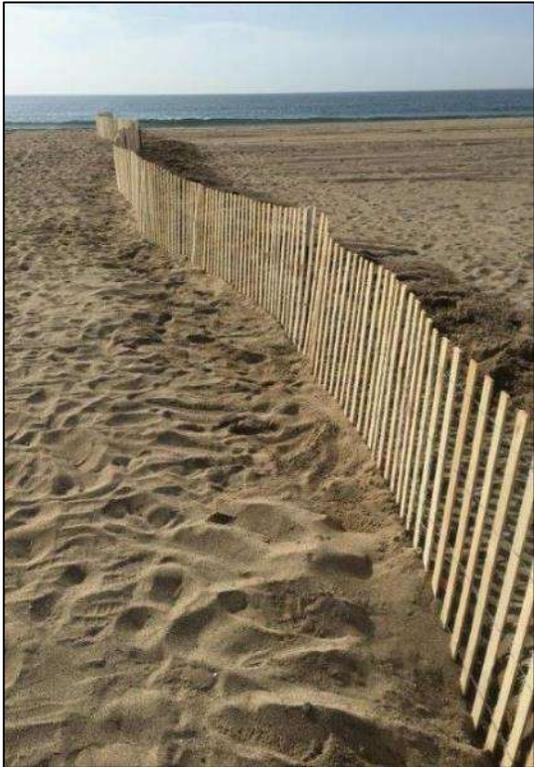
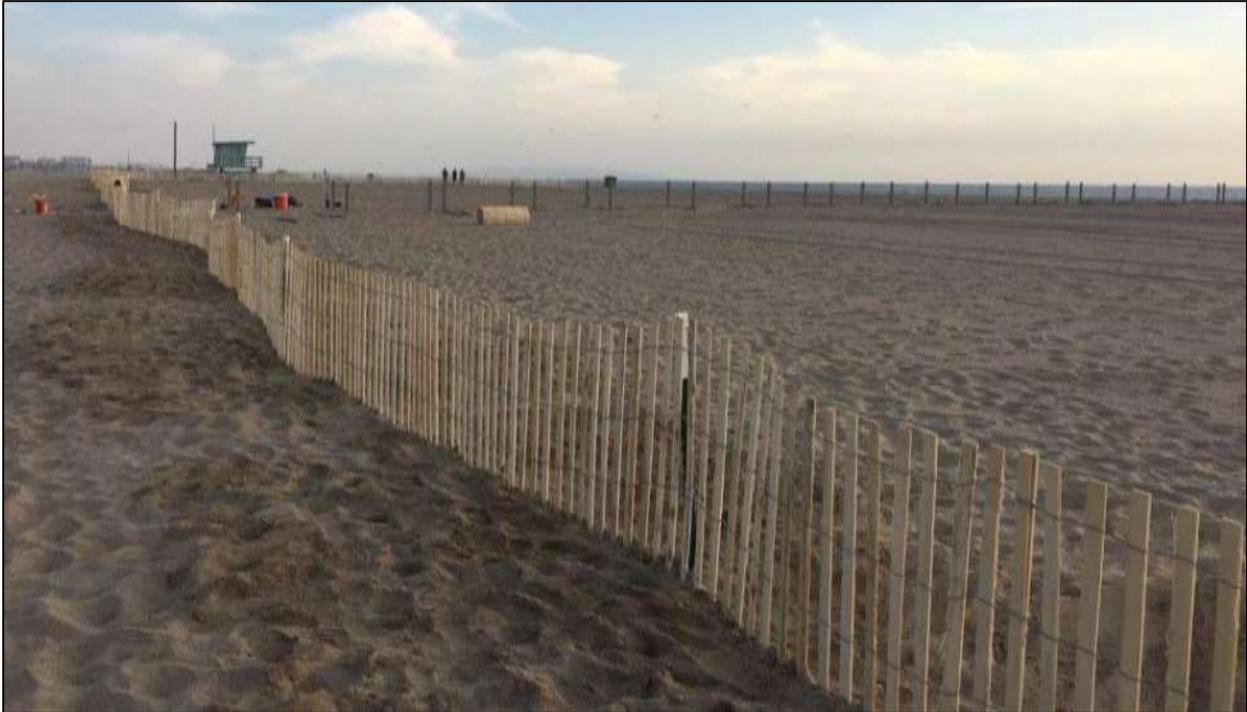
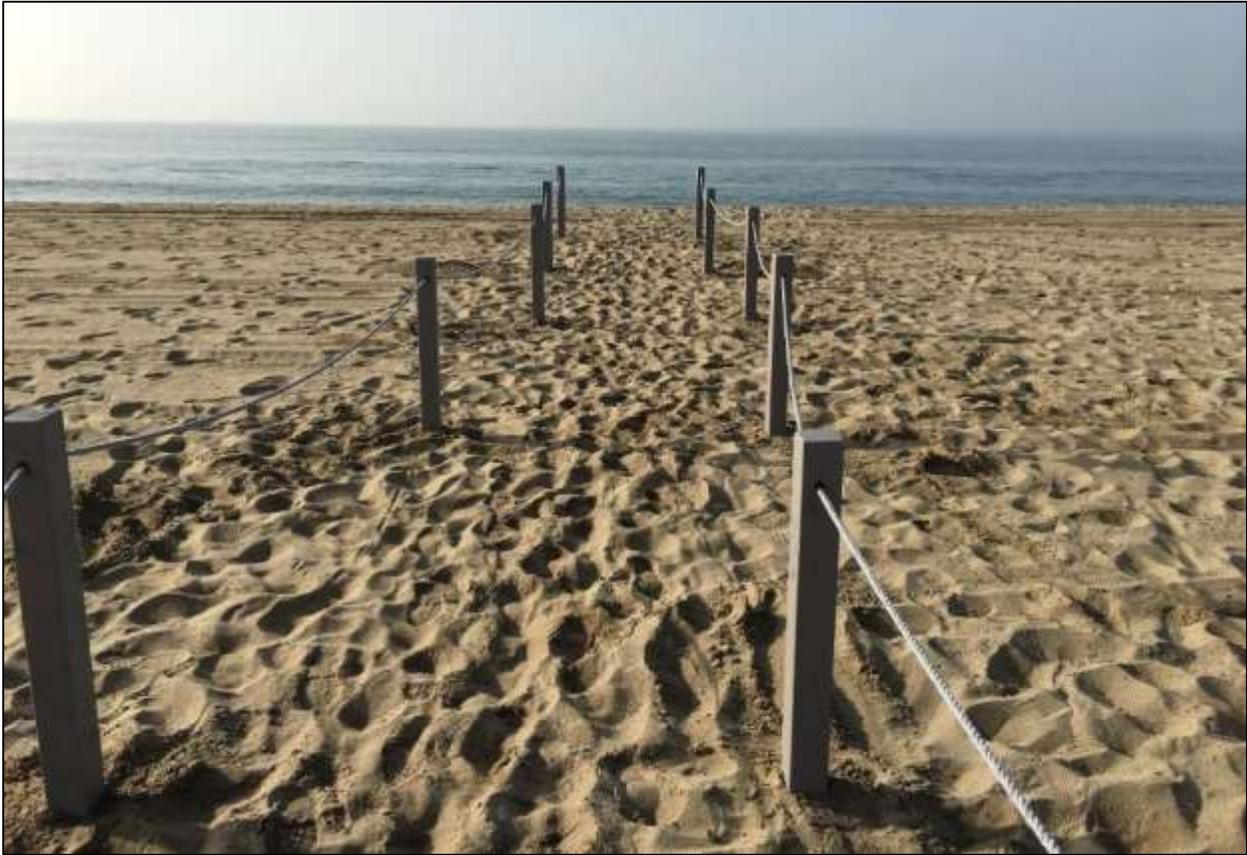
Figure 12. Installation series of the sand fence and symbolic rope pathway on 6 and 7 December 2016.

Both the sand fence and the symbolic fence were installed on 6 and 7 December 2016 with the help of TBF staff, volunteers, and the City of Santa Monica beach maintenance staff. Subsequent photographs document the installation of the sand fence (Figure 12). We are grateful to all of the help from volunteers and the questions and support from interested members of the public during the installation.

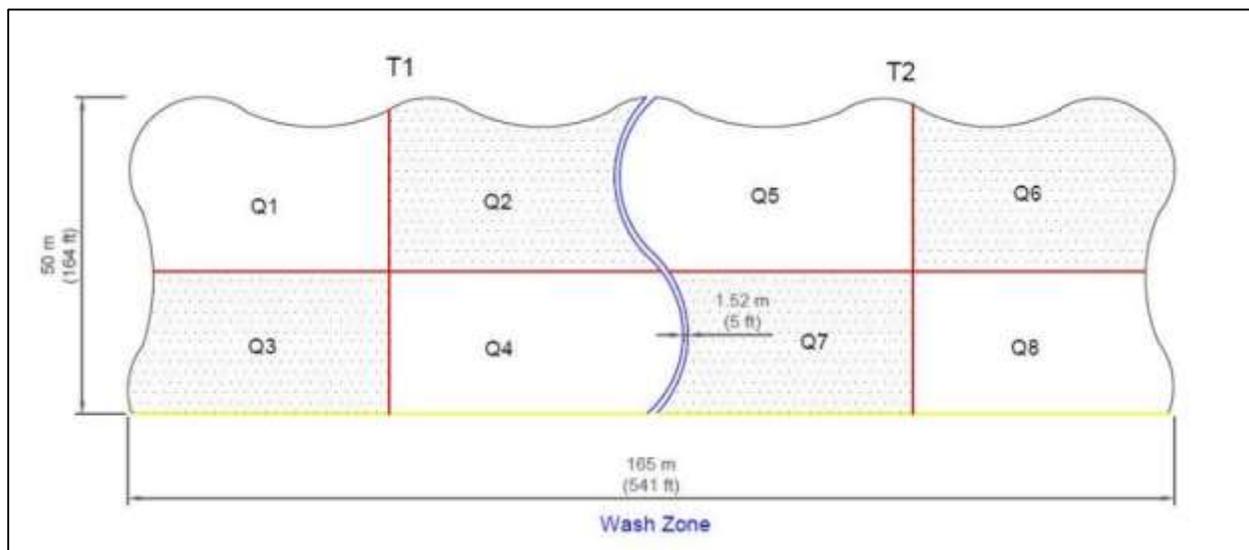
Figure 13. Restoration site graphic design, including two treatment plots (T1 and T2).

The restoration site fence placement and symbolic pathway are shown in Figure 13. Treatment 1 (T1) and Treatment 2 (T2) identify the north and south sections, respectively, of the restoration area, separated by the symbolic pathway. T1 and T2 are further segmented into quadrants. Spotted quadrants (Q2, 3, 6, and 7) received the soaked and hand sown method of dispersal and the others received the broadcast and raking method of dispersal (Figure 14). This allowed for a comparative assessment of vegetation growth using both methods. The seed mix is shown in Figure 15.

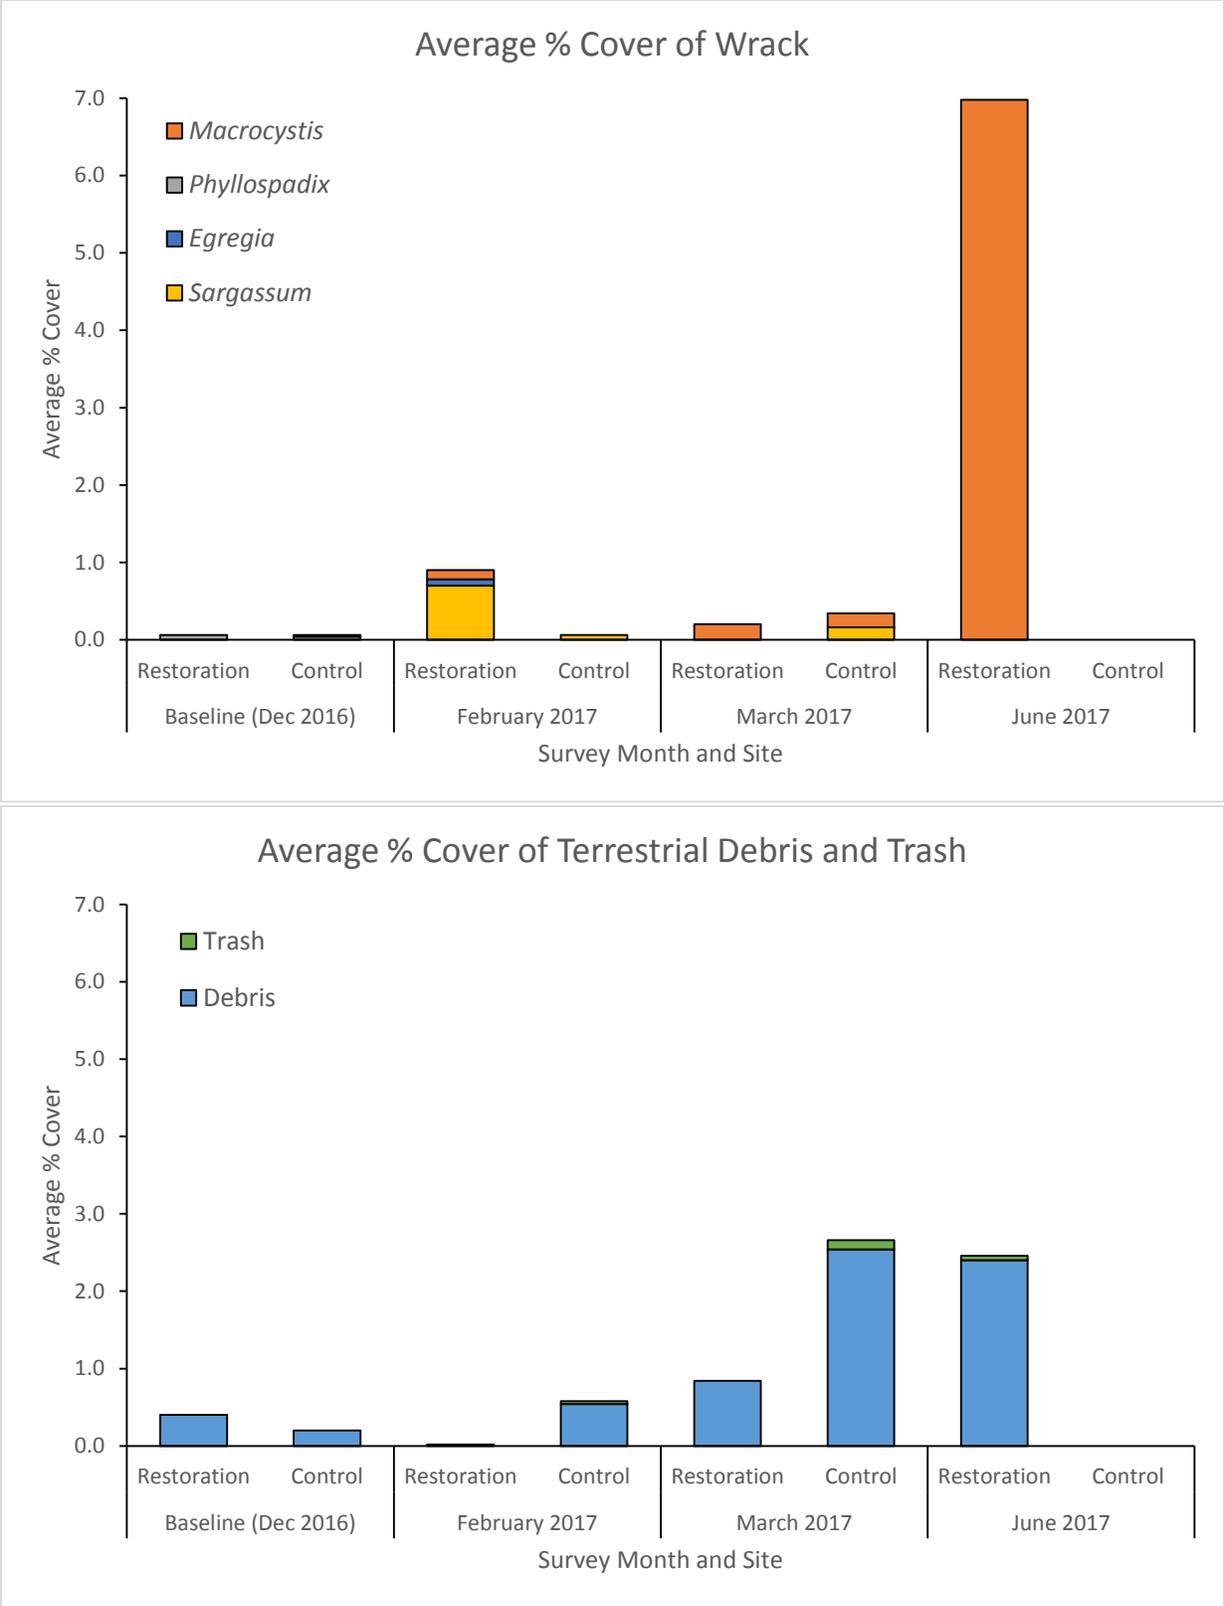
Figure 22. Average percent cover of wrack by species (top) and terrestrial debris and trash (bottom) in the restoration area and control site across the four surveys.

Terrestrial debris and trash were variable throughout the survey months (Figures 21 and 22). The bottom photograph in Figure 22 shows some small sticks and twigs classified as terrestrial debris. It also shows small bits of *Phyllospadix torreyi*, or surfgrass. Interestingly, during the February and March surveys, average trash cover was found to be higher at the control sites than within the restoration (Figure 22). This may be due to less frequent grooming during the non-summer months, or the maintenance of the restoration area through hand-removal of trash accumulation. Trash was found to be at zero percent cover for both areas during the December baseline surveys, and slightly higher (0.06%) within the restoration area during the June surveys (Figure 22). Terrestrial debris, which includes leaf litter, sticks and twigs, and other natural debris, was found to vary between the restoration and control sites and across the survey months.

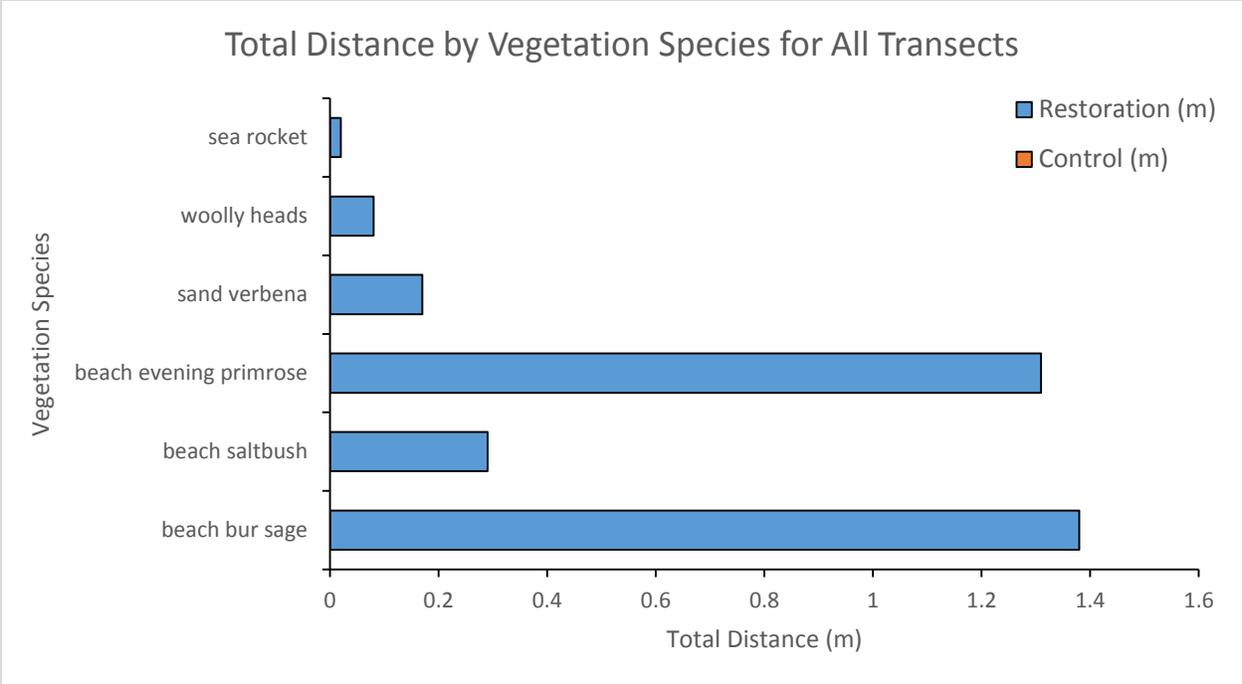
Figure 23. Total distance (m) by species for all transects combined.

All four of the seeded vegetation species germinated within and immediately adjacent to the restoration area (i.e. beach evening primrose, sand verbena, beach bur sage, and beach salt bush) (Figure 23). Additionally, two other vegetation species germinated within the project area: woolly heads (annual native herb, *Nemacaulis denudata*) (Figure 24) and sea rocket (non-native, *Cakile maritima*) (Figure 25). Woolly heads, a native and possibly rare species variant, was not in the seed mix as confirmed by the seed provider; thus, it is probable that there was either an existing seed bank for this species already along Santa Monica Beach, or that it was transported by wind, waves, birds, or humans. Combining all transects surveyed, the highest proportion of cover was found to be beach bur sage, followed closely by beach evening primrose. Sea rocket had the least cover of all vegetation species and was periodically removed by hand from within the restoration area.

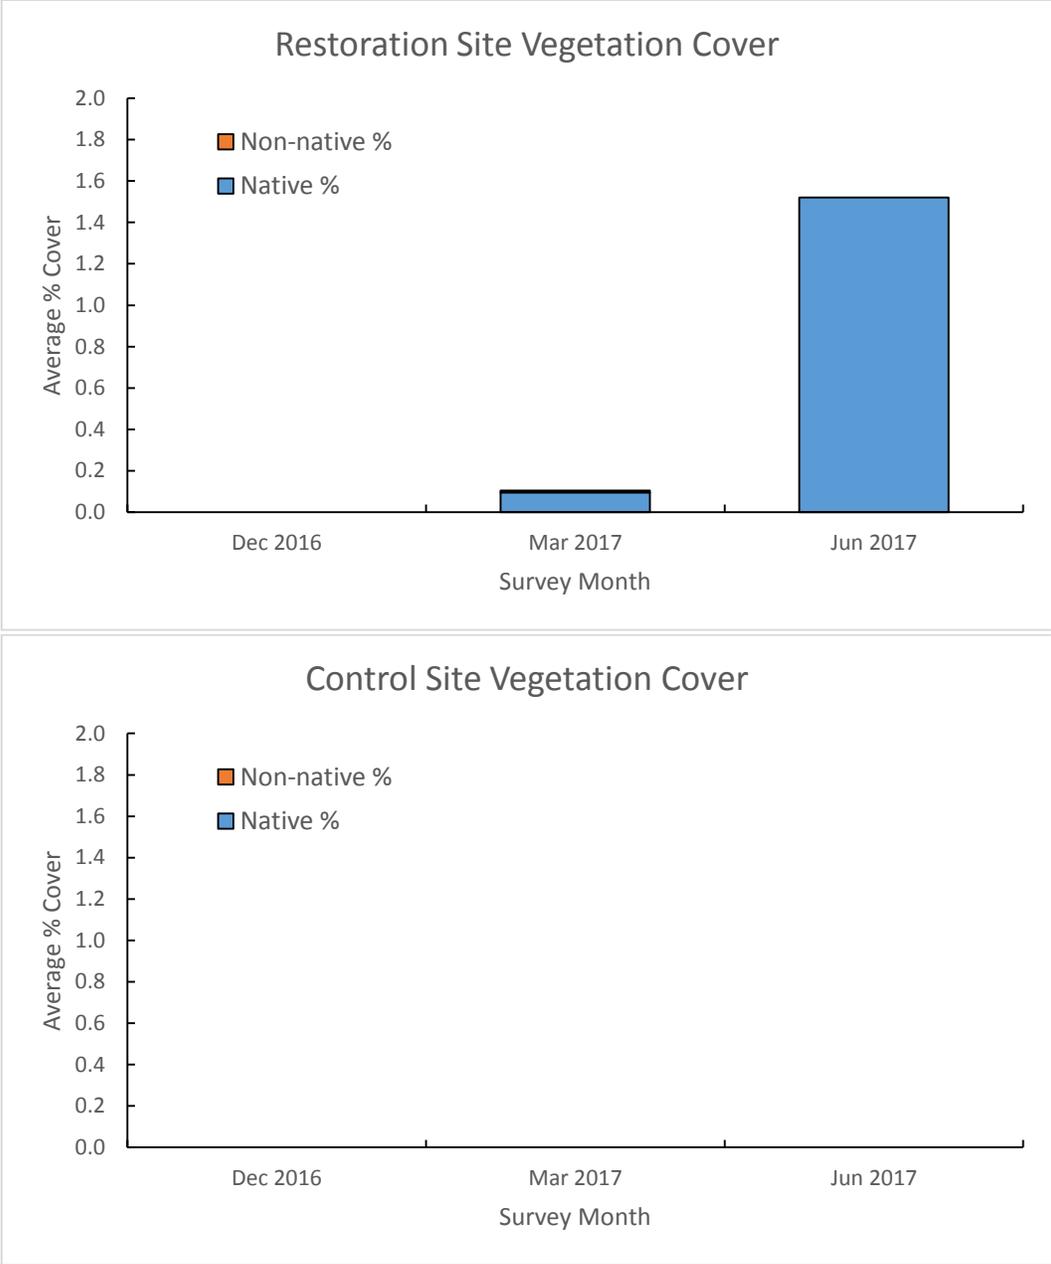
Figure 26. Average native and non-native vegetation cover during all surveys within the restoration area (top) and at the control site (bottom).

Vegetation cover assessed during the baseline (December 2016) surveys at within both the restoration area and control site was zero (Figure 26), and remained zero at the control site throughout all survey times. Native vegetation cover was much higher than non-native cover (sea rocket) during all surveys, and the native cover increased over time to a maximum overall percent cover of just over 1.5% during the June survey (Figures 26 and 27). Vegetation cover was highest on the eastern portion of the restoration area, becoming sparser towards the water line. Vegetation is likely to continue to increase and become more complex over time, though naturally-occurring coastal strand habitats also usually have a significant portion of bare sand, even after becoming mature vegetation communities.

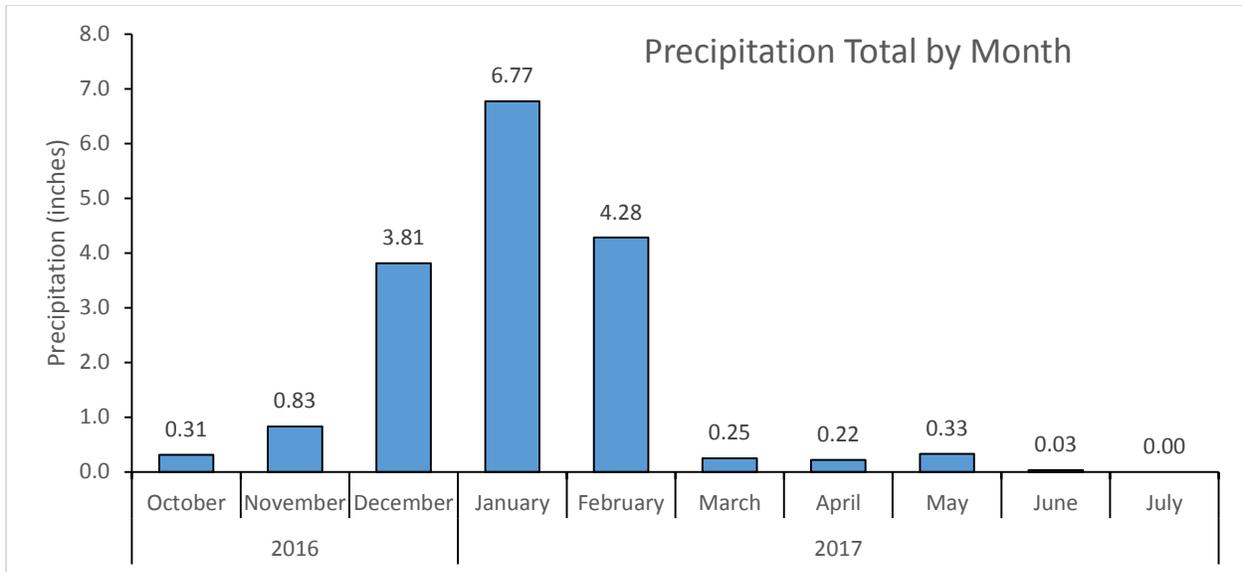
Figure 36. Precipitation total (inches) by month for the water year (beginning on 1 October 2016 through 31 July 2017). Data were downloaded from [Los Angeles County Department of Public Works](#) Electric Avenue precipitation gage on 29 August 2017.

The total rainfall for the water year (beginning on 1 October 2016 through 31 July 2017) was 16.83 inches, as measured at the Los Angeles County Department of Public Works Electric Avenue precipitation gage (closest gage to the restoration area). The highest rainfall month was 6.77 inches in January 2017, with several large storm events (e.g. over 2 inches on 22 January 2017) (Figure 36).

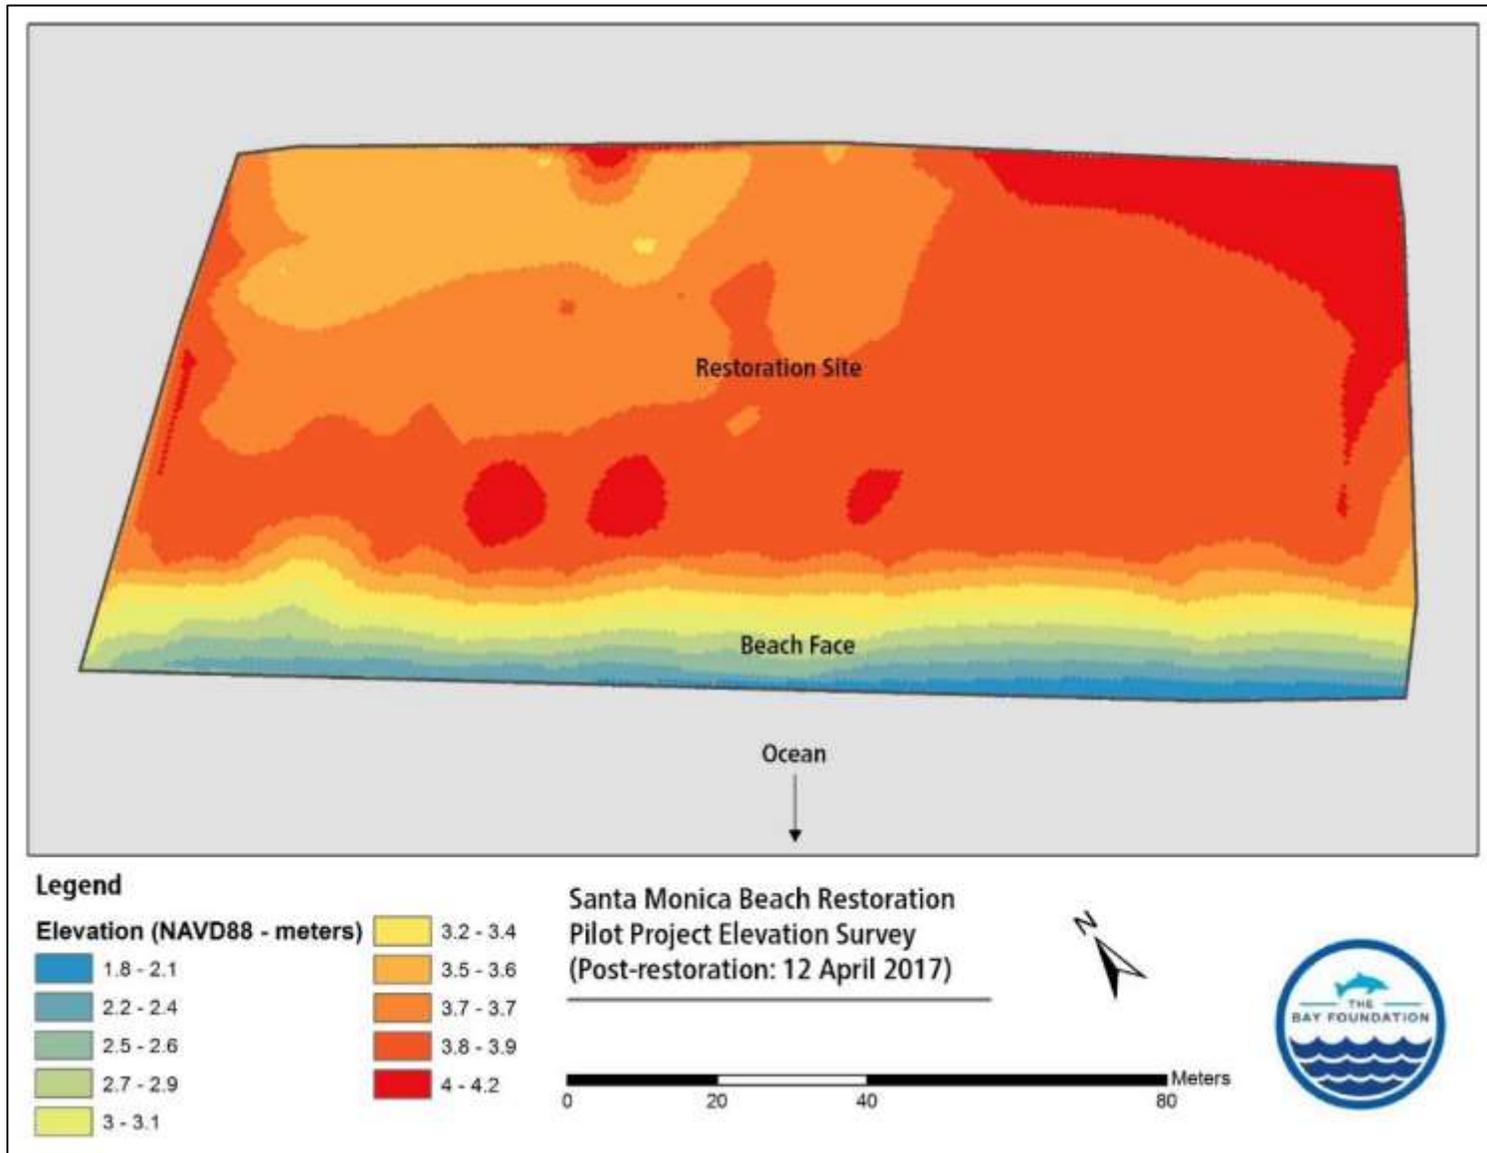
Figure 37. Topographic map of restoration area (survey conducted on 12 April 2017).

A high-resolution elevation survey using a Trimble Geo7x GPS was conducted on 12 April 2017. Elevation points were then analyzed in a geographic information system (GIS) to create a topographic surface of the restoration site. Figure 37 displays the topographic map results from the GPS elevation survey, approximately four months after the fence installation and seeding of the restoration area. As the transect data indicate, the area was fairly flat and uniform prior to the restoration. By the time of the April survey, the beginning of sand build up was evident along the fence line, especially the northwest fence and the southeast corner of the restoration area (Figure 38).

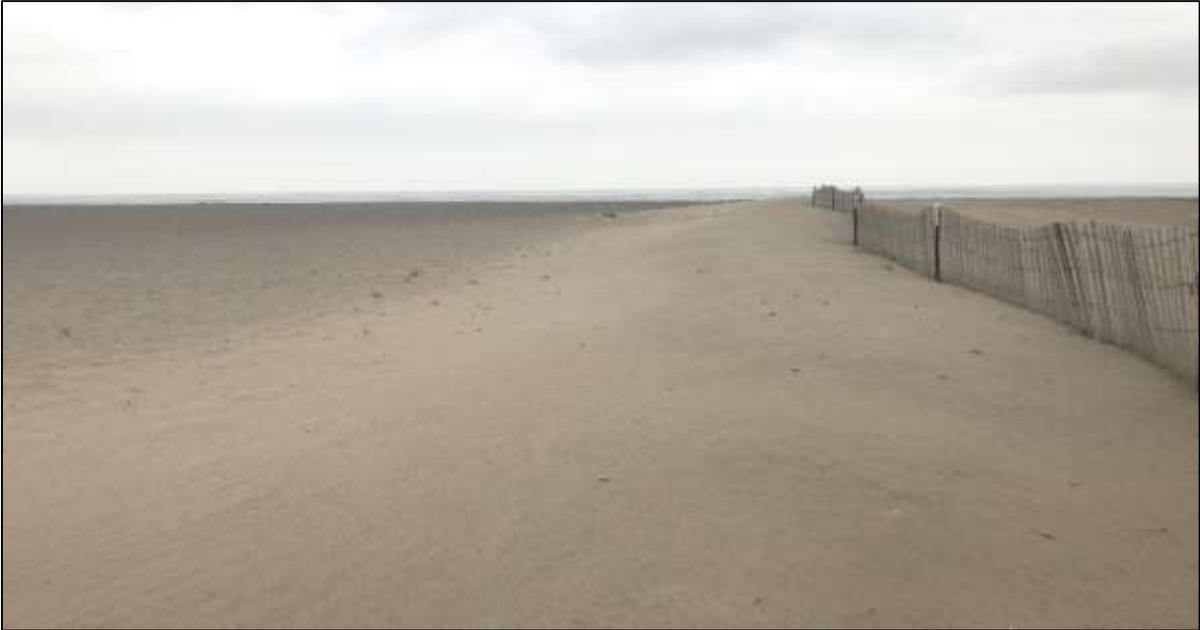
Figure 38. Photograph of sand build-up along the northern fence line in the restoration area (9 May 2017).

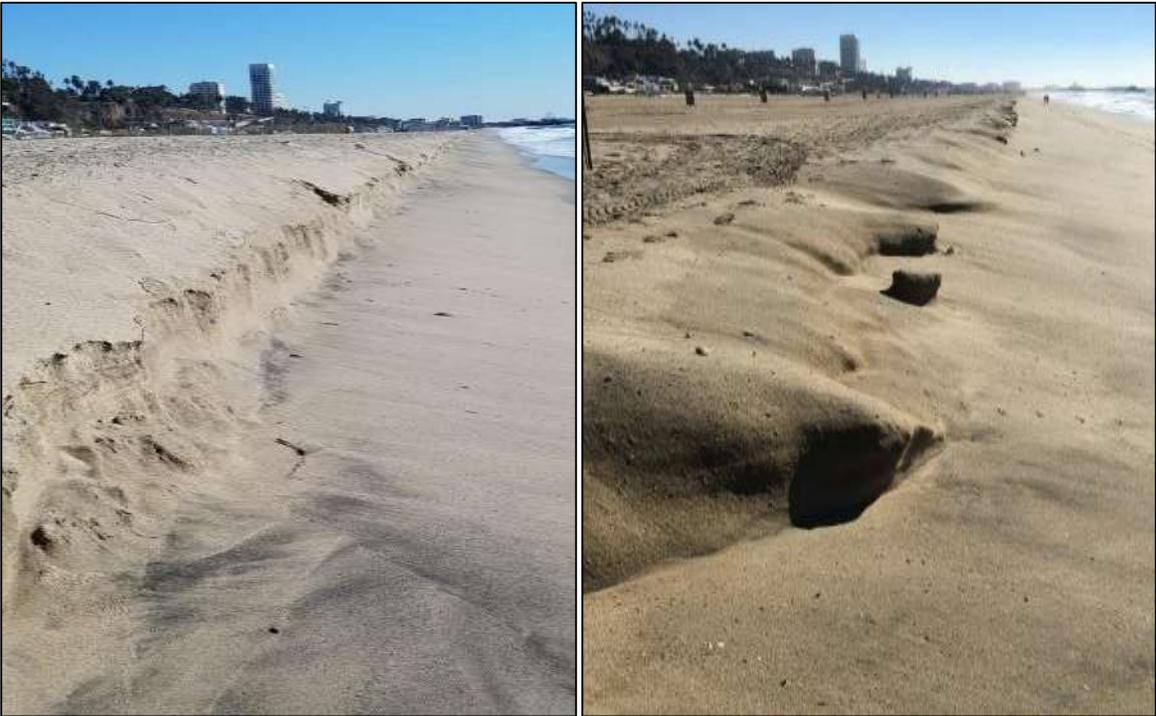
Figure 39. Berm topography (left: 17 December 2016, right: 25 January 2017).

The sand berm adjacent to the ocean water line fluctuated and varied with the tidal patterns, from an initial steep slope in December 2016 (Figure 39), to a much more gradual slope by mid-2017. The berm edge receded during the winter and accreted during the summer months. Additional surveys to track the berm fluctuations over time will be necessary.

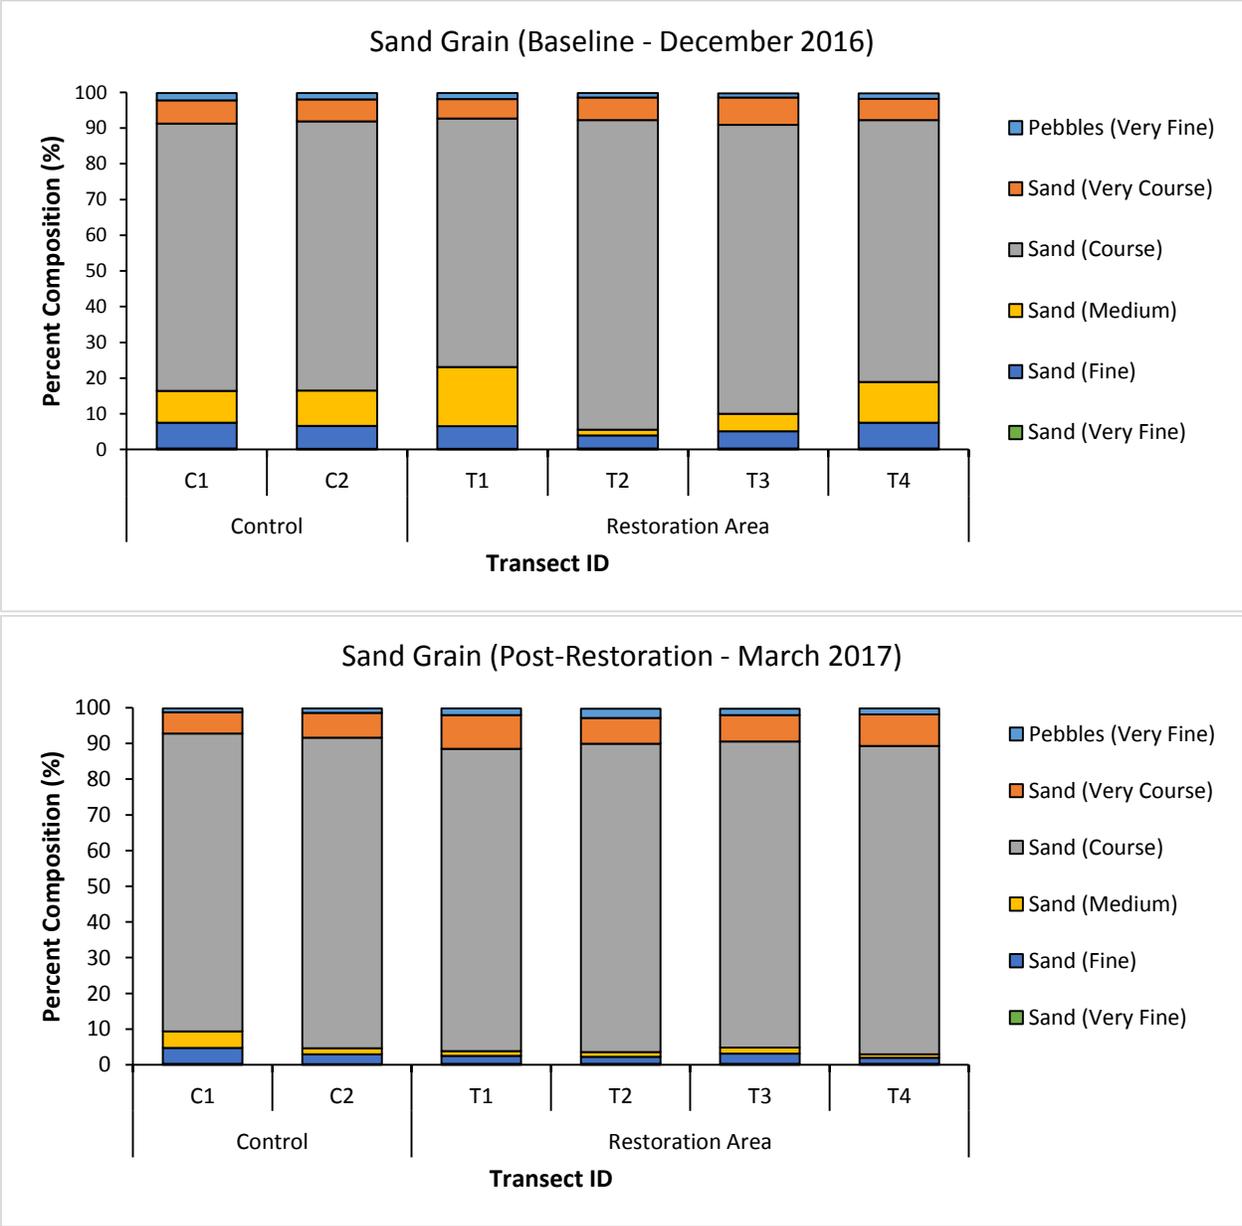
Figure 40. Baseline (top) and post-restoration (bottom) sand grain results for all transects (dry sample averages).

A set of baseline and post-restoration sand samples were collected from two control transects and four transects on 13 December 2016 and 24 March 2017, respectively. Three samples were collected from each transect (approximately 3 meters south of the transect line to avoid footprints), including two dry samples off the 15m and 30m transect meter mark, and a wet sample near the waterline on the beach face. Samples were weighed before and after drying to measure moisture content, then each sample was sorted using a set of sieves measuring from 2mm (very fine pebbles) to 0.06mm (very fine sand). In general, dry sand within the restoration site (averaged for 15m and 30m) saw a shift in grain size from medium and fine sand to course sand (Figure 40). Additionally, all post-restoration samples within the restoration site had a small increase in very fine pebbles, whereas control sites did not.

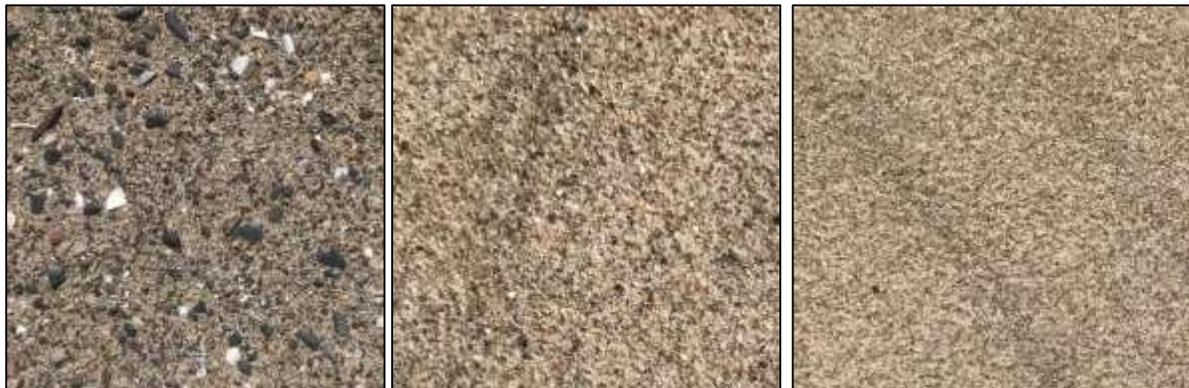
Figure 41. Sand grain examples in restoration site [left: pebbles (very fine); middle: course sand; right: fine to very fine sand].

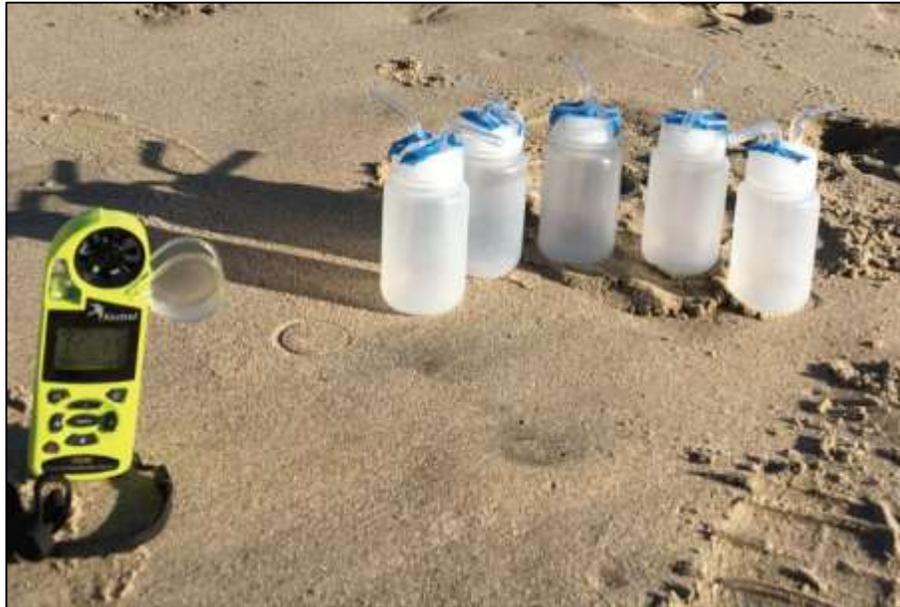
Figure 42. MWAC samplers deployed at restoration site.

Sand transport measurement protocols involved using Modified Wilson and Cooke (MWAC) samplers to determine actual in-field sand transport rates (Figure 42). MWAC samplers were deployed for 30 minutes to one hour on multiple field surveys and failed to collect sand. This protocol will continue to be attempted during future surveys, targeting high wind conditions to maximize sand collection success. Additionally, data collected in the field combined with sand grain analyses was used in an empirical model to calculate wind-blown sand transport (Hsu 1981). Hsu’s calculations will provide a future

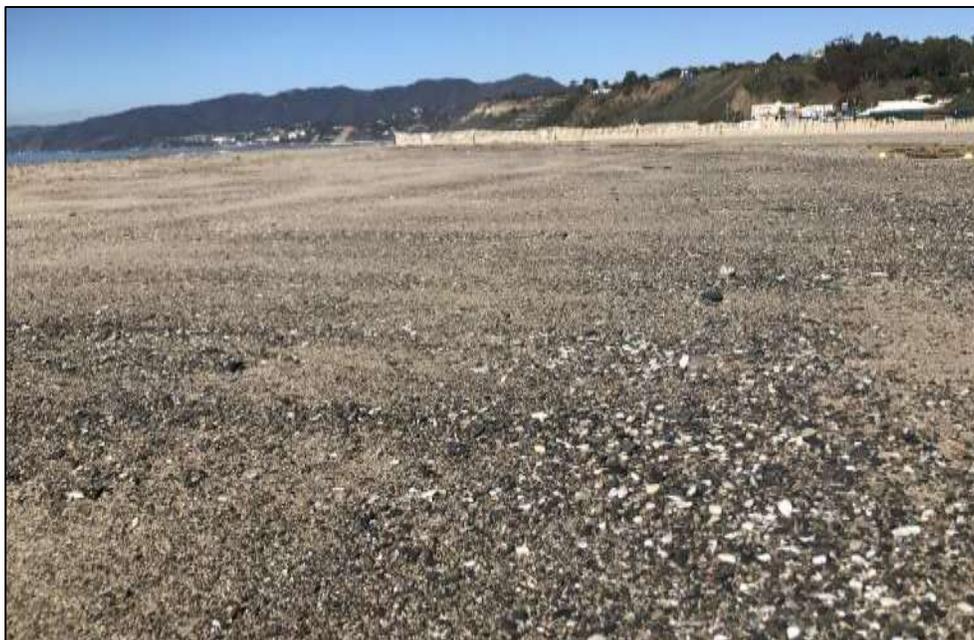
Figure 43. Cobble present in site after high king tide events (25 January 2017).

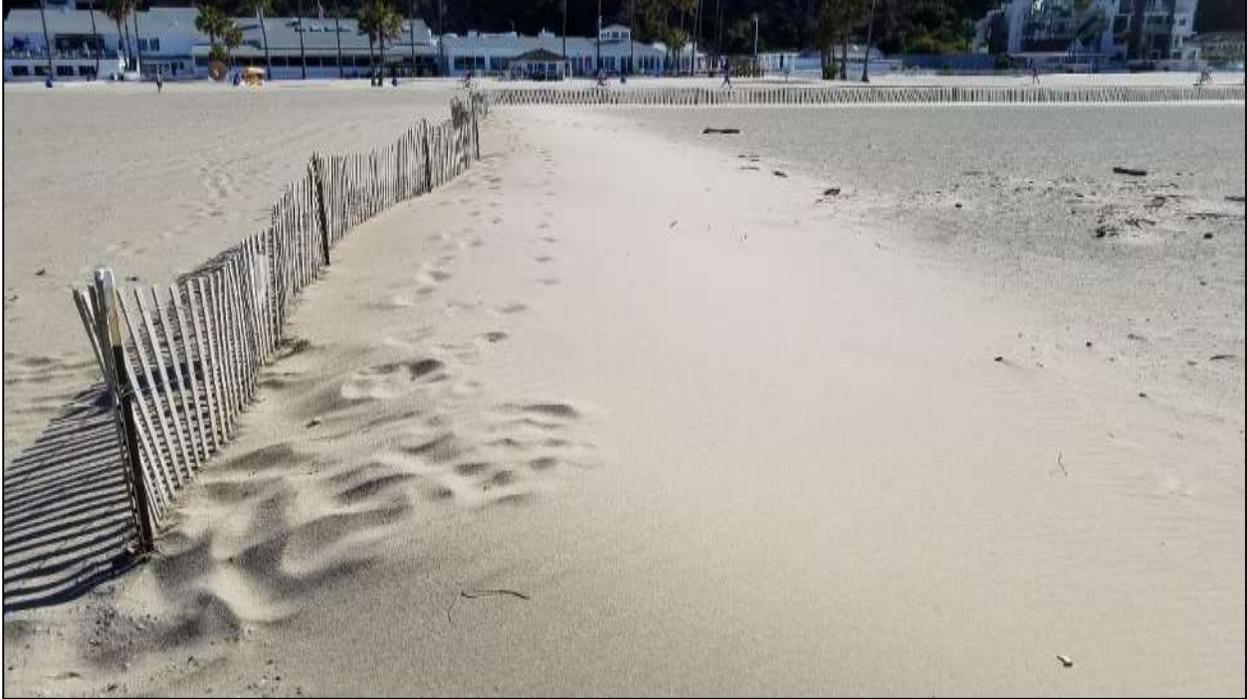
Figure 44. Sand accretion along fence in restoration site (29 April 2017).

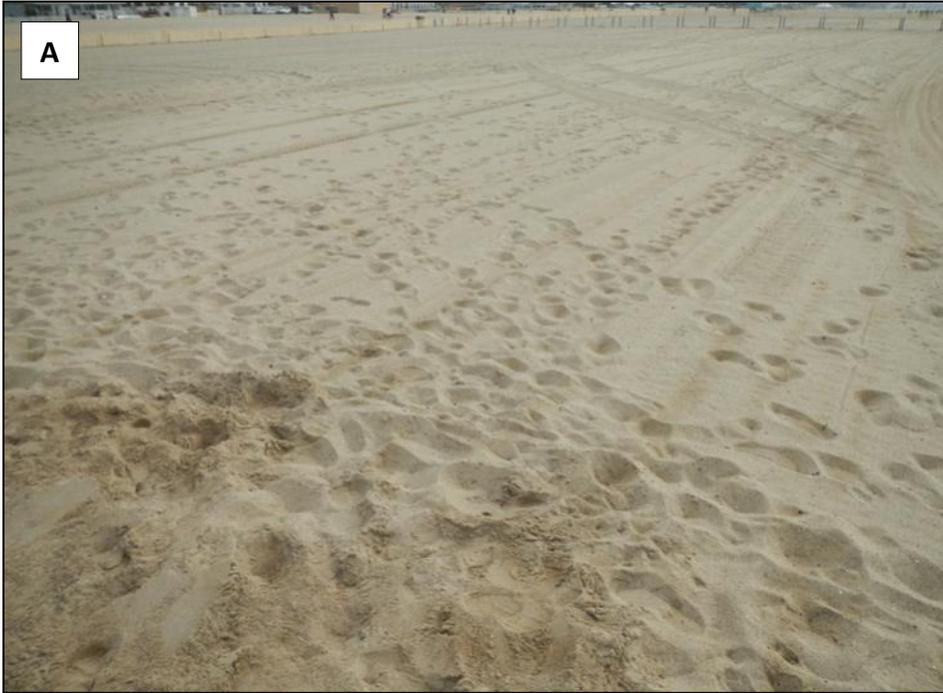
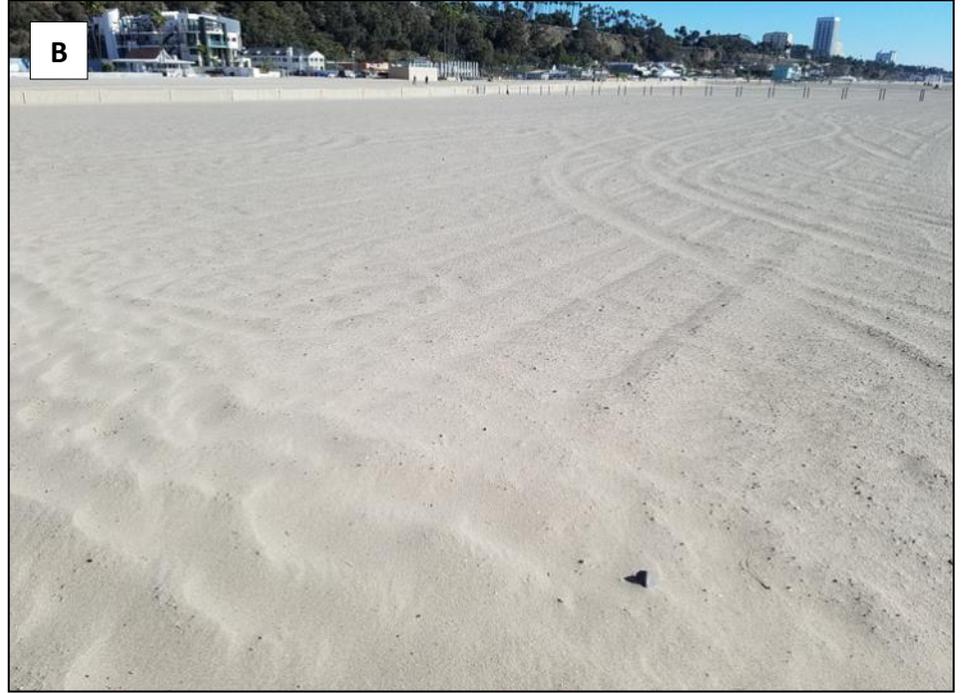
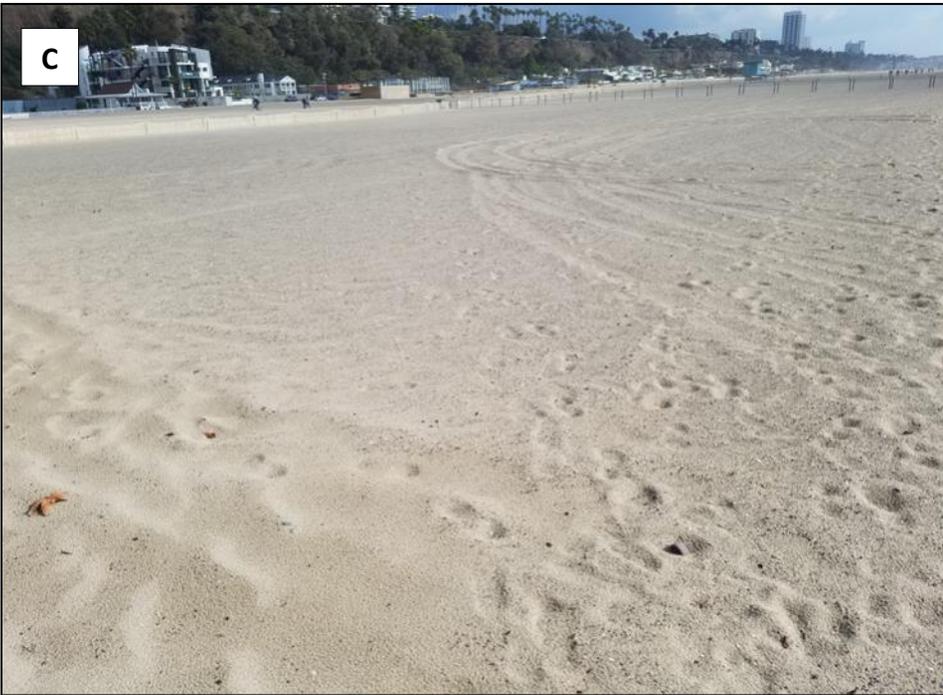
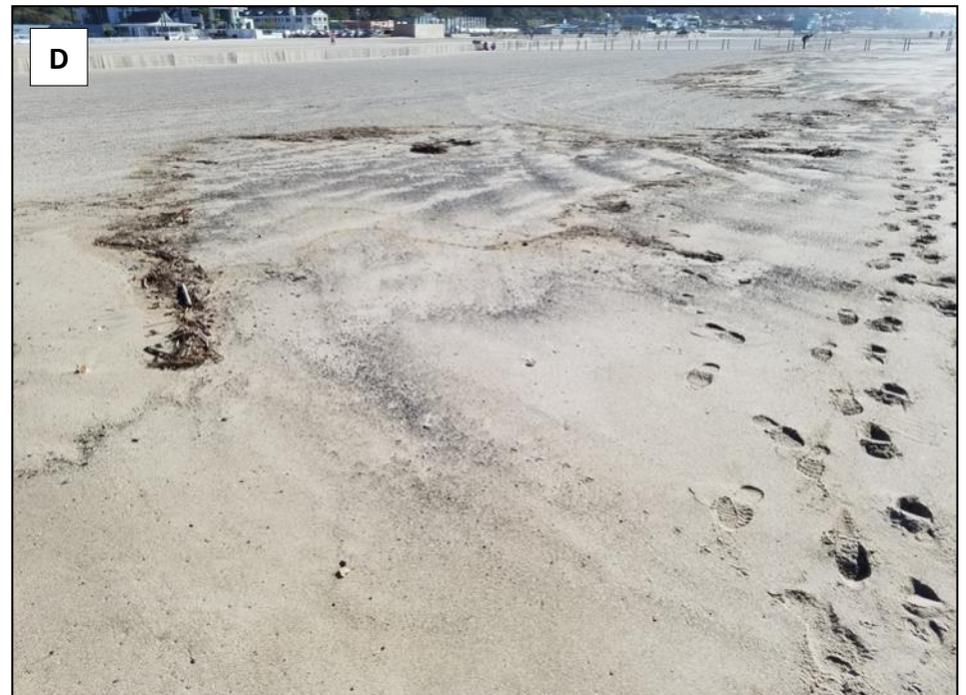
Figure 45a. Photo Point 1A (bearing 88°) surveyed on (A) 13 December 2016; (B) 17 December 2016; (C) 13 January 2017; (D) 25 January 2017.
