Santa Monica Beach Restoration Pilot Project

Year 1 Annual Report

August 2017

Prepared by: The Bay Foundation

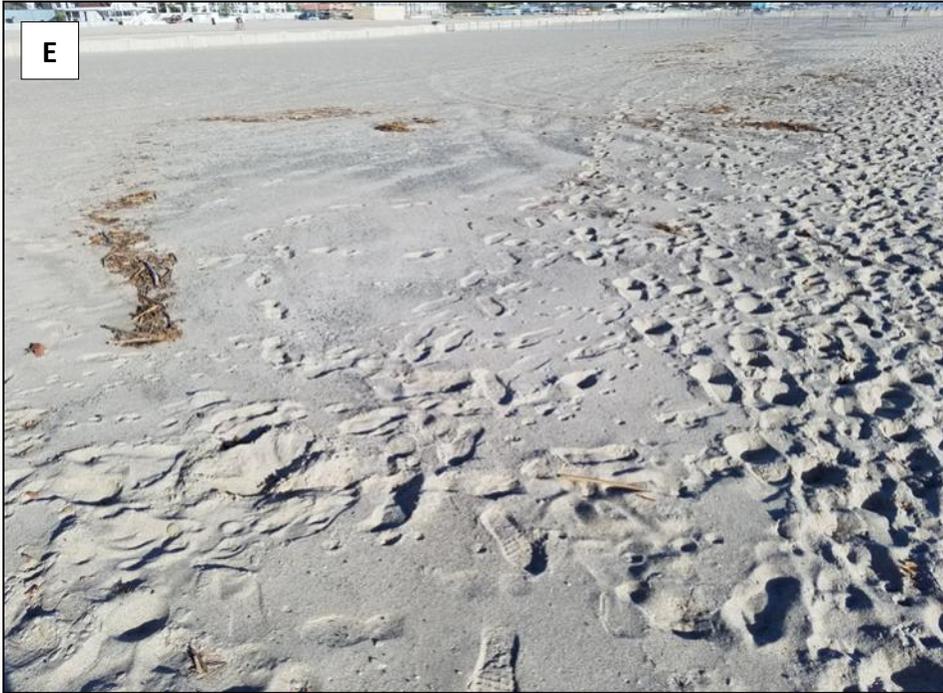
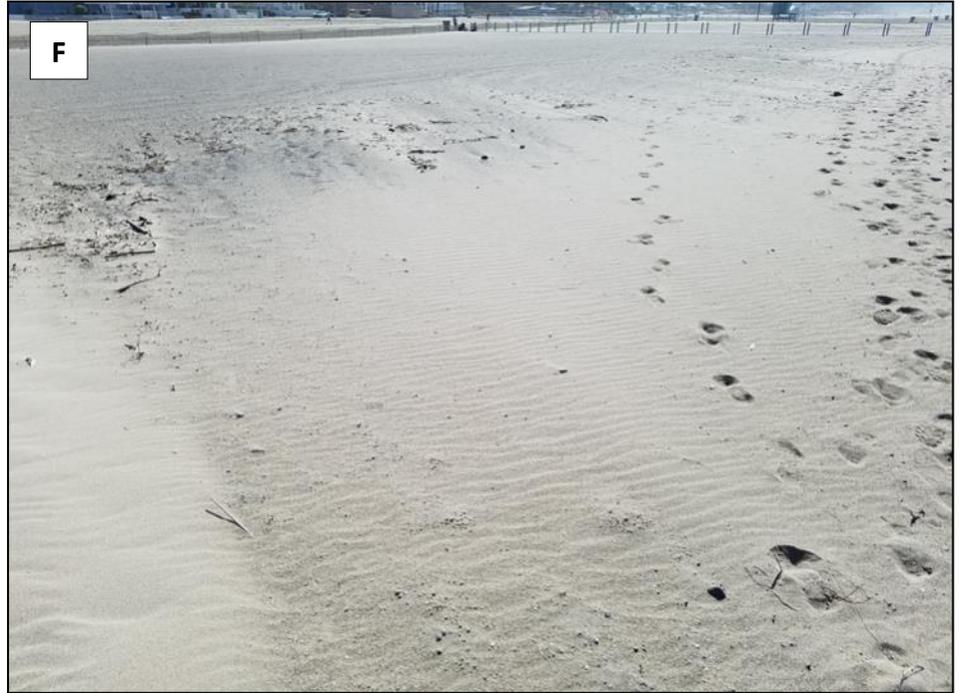
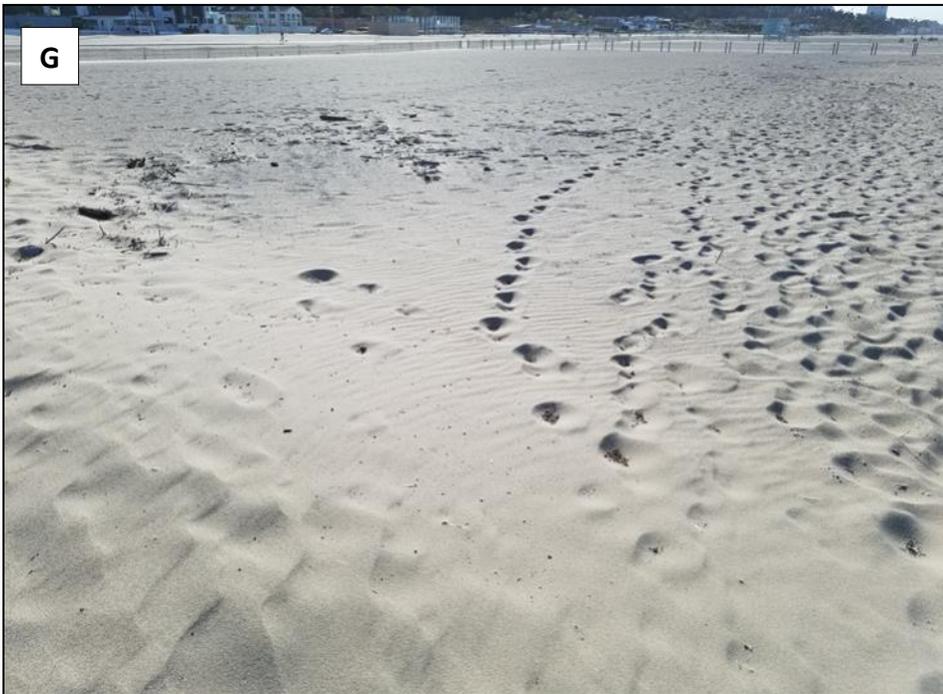
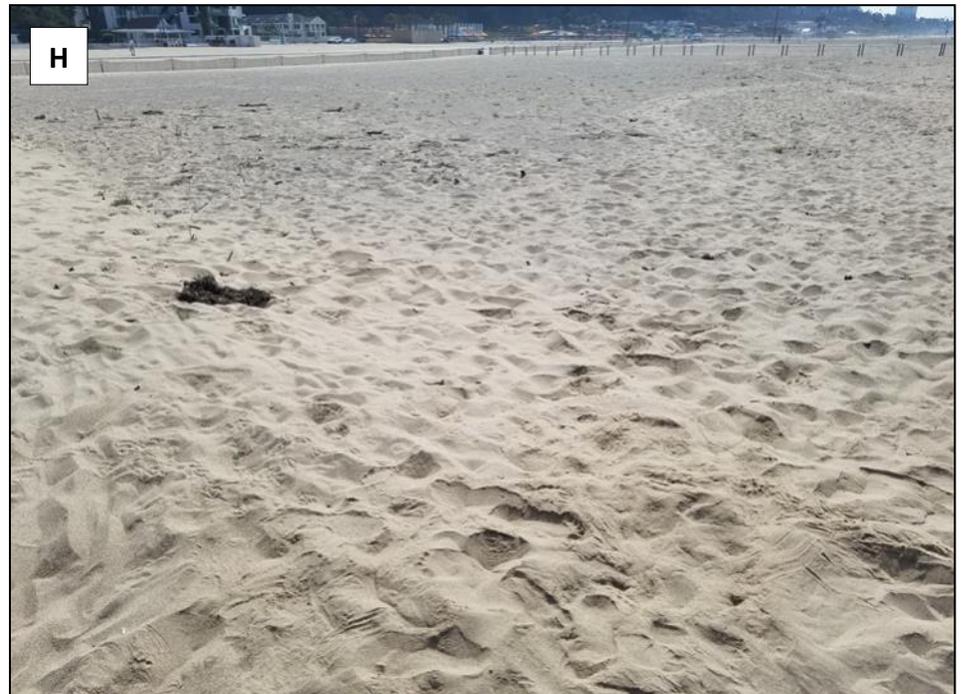
Figure 45b. Photo Point 1A (bearing 88°) surveyed on (E) 4 February 2017; (F) 24 March 2017; (G) 25 April 2017; (H) 21 August 2017.

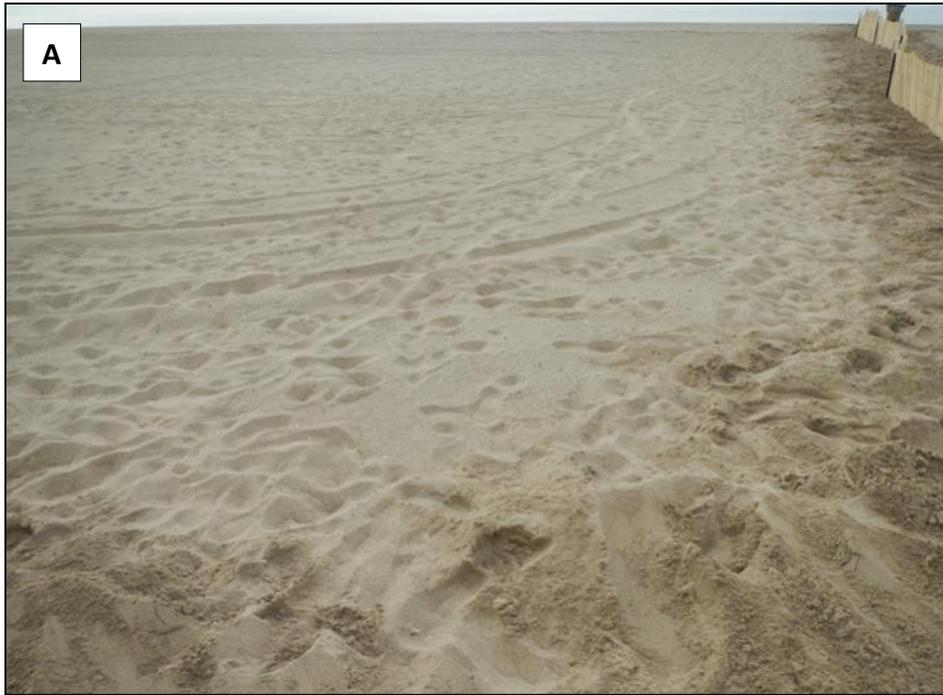
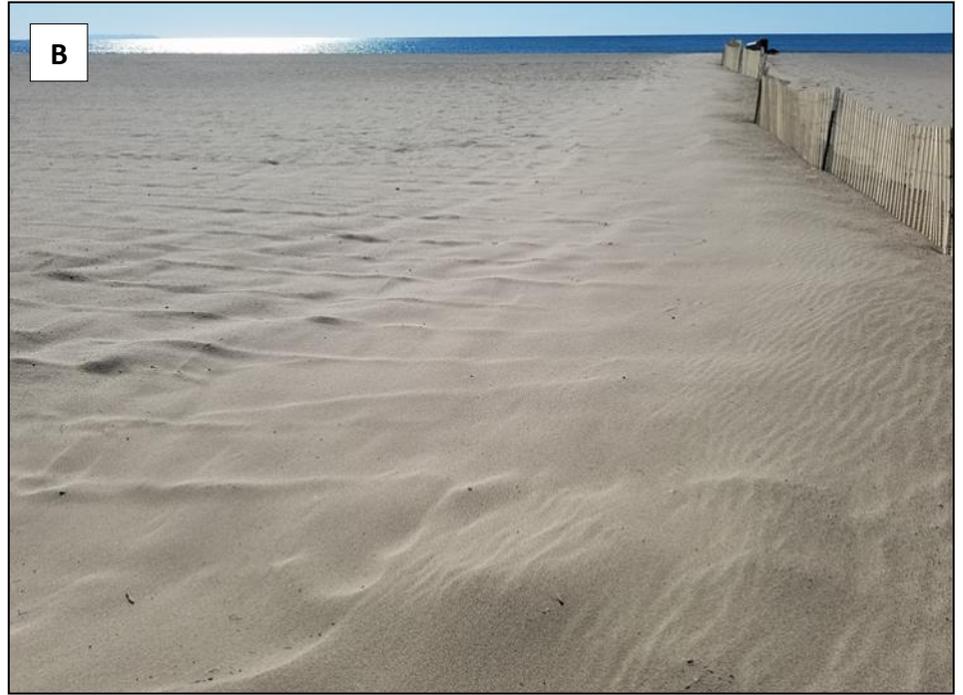
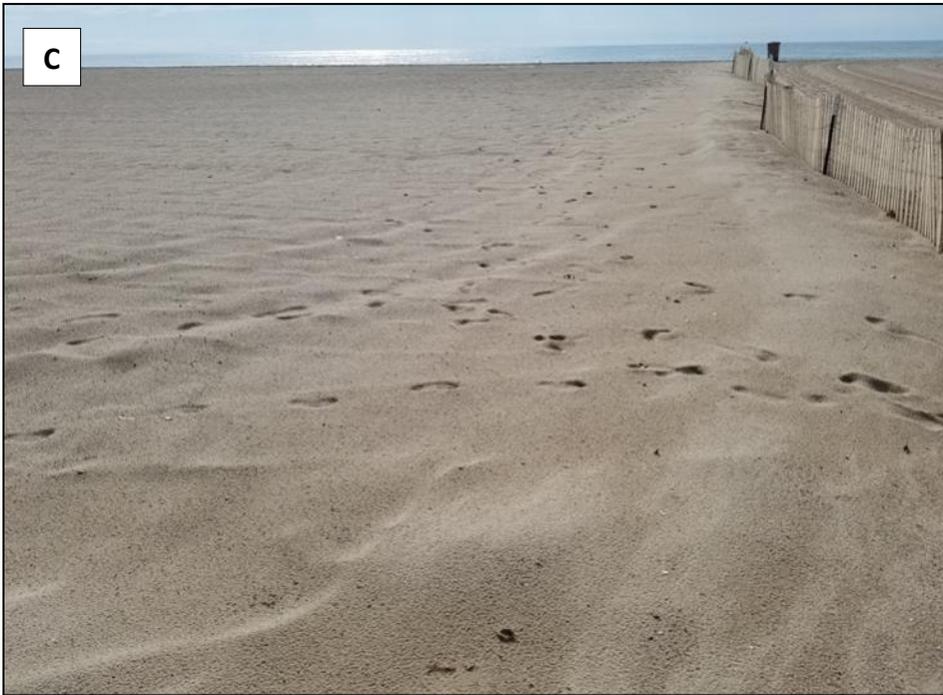
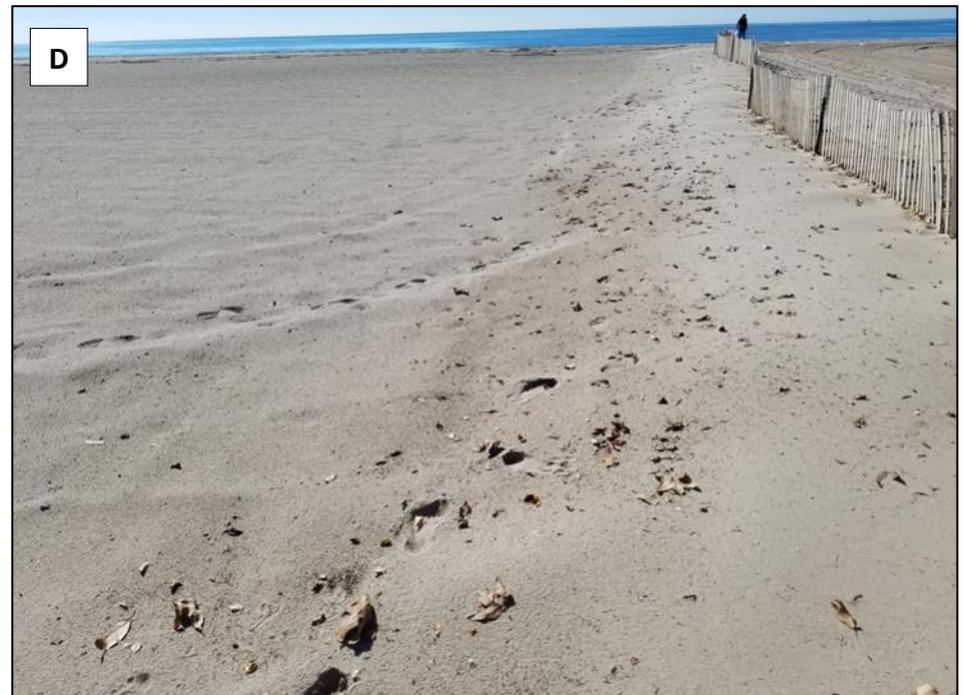
Figure 46a. Photo Point 1A (bearing 210°) surveyed on (A) 13 December 2016; (B) 17 December 2016; (C) 13 January 2017; (D) 25 January 2017.

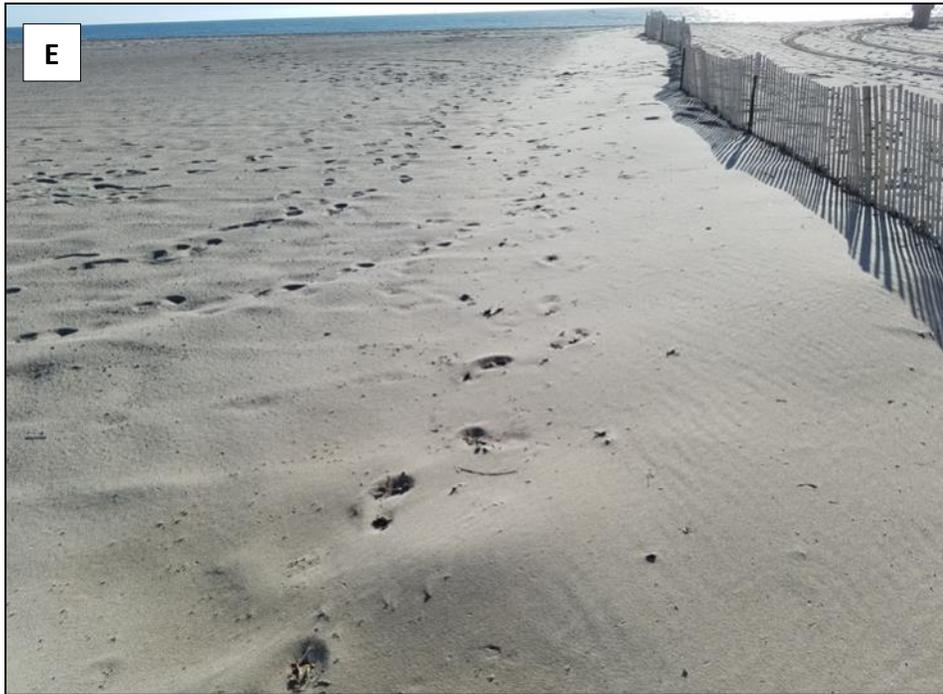
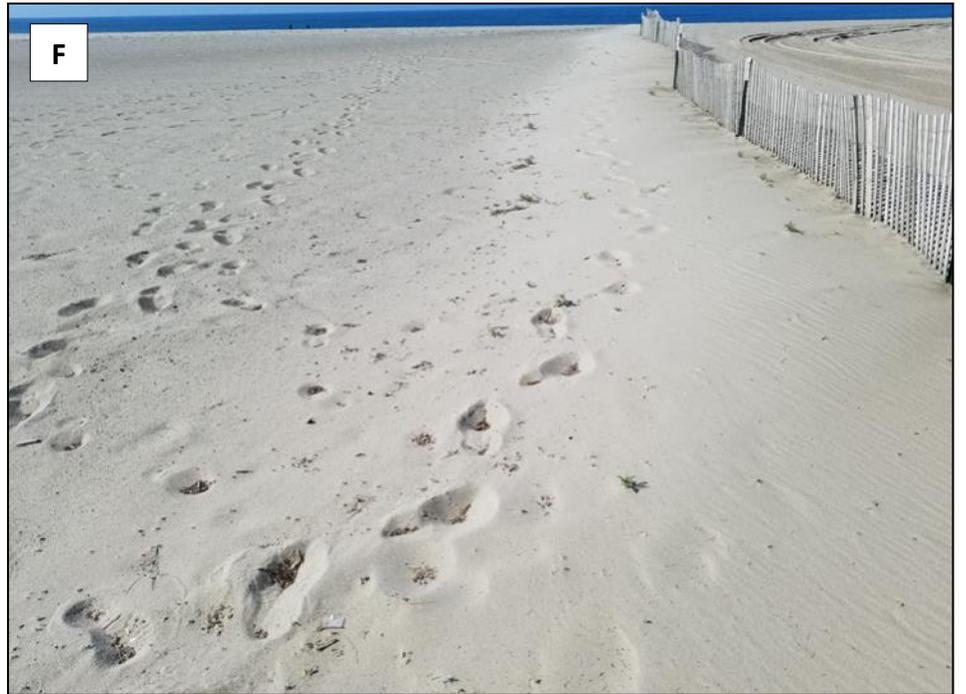
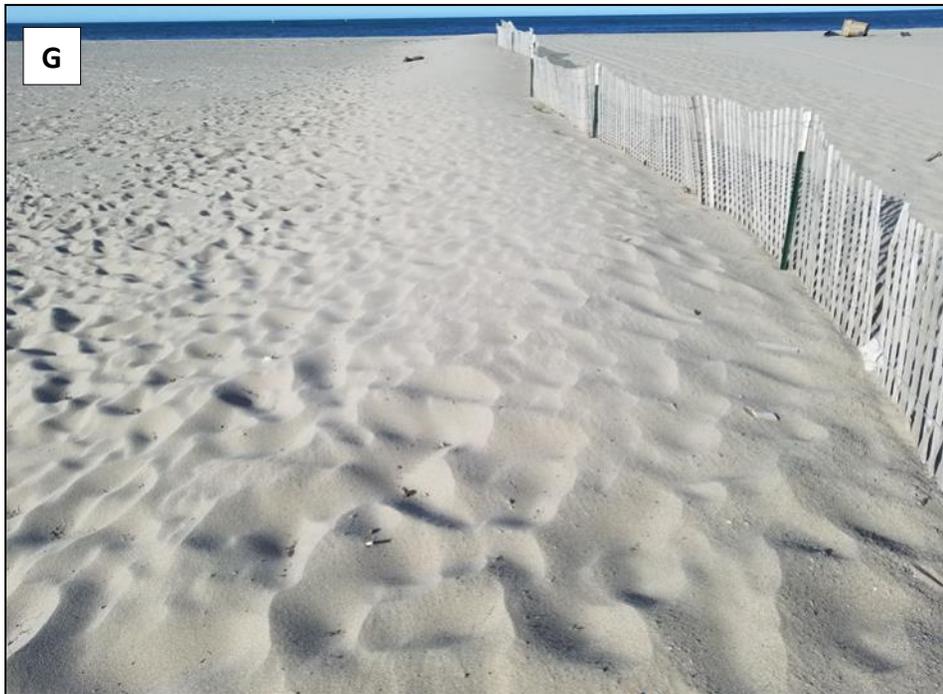
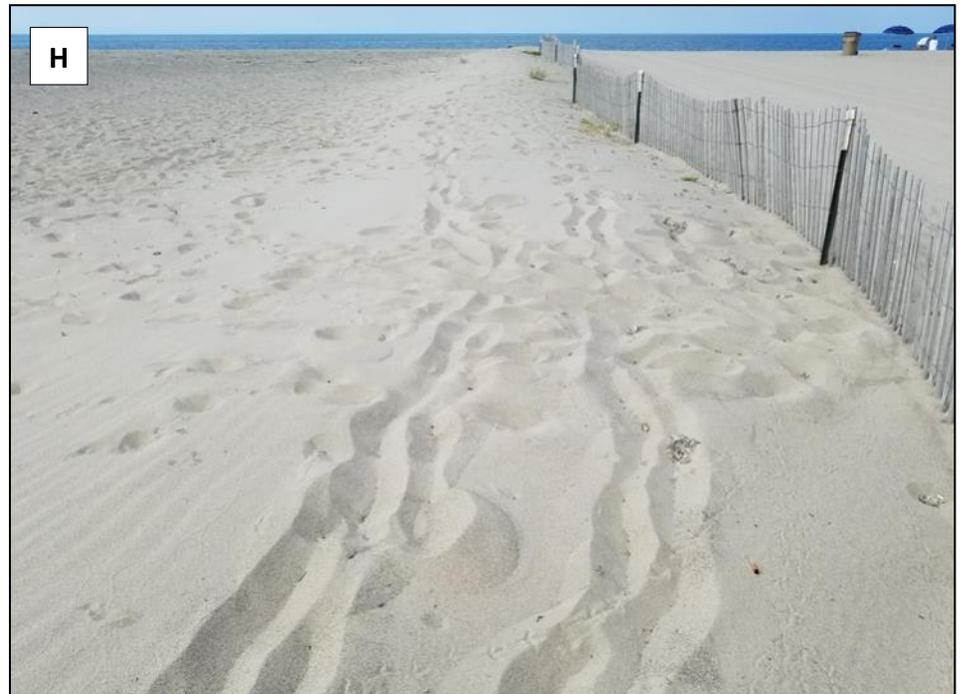
Figure 46b. Photo Point 1A (bearing 210°) surveyed on (E) 4 February 2017; (F) 24 March 2017; (G) 25 April 2017; (H) 21 August 2017.
