Los Angeles Living Shoreline Project

Restoration and Monitoring Plan for Beach and Bluff Habitat

June 2021

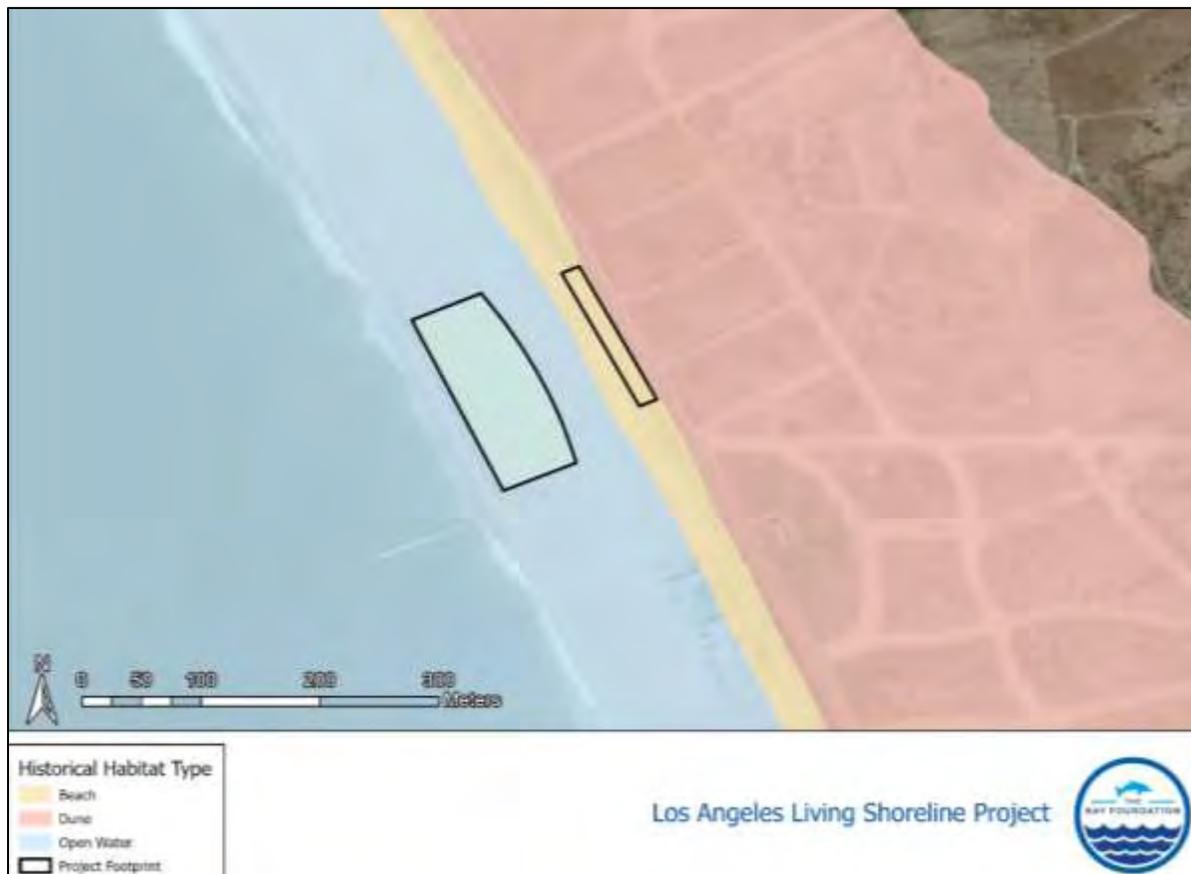
Figure 2. Historical distribution of open water, beach, and dune habitat types overlaid onto present-day aerial imagery of the project site. Historical habitat types were determined by the Southern California Coastal Water Research Project 2010 analysis on the [Historical Ecology of southern California Coastal Wetlands](#), which digitized T-sheets (historical coastal topographic maps) from 1851 to 1889.

Figure 2 depicts the historically narrow beach backed by dunes, where the present-day project footprint was historically submerged. Figure 3 – Figure 5 show a historical photograph series replicated from the USC Digital Commons Library beginning with Figure 3 in 1921 prior to nourishment activities (historical mouth of Ballona Creek is to the left). Figure 3 – Figure 5 illustrate Dockweiler Beach and surrounding areas in the 1950's after nourishment.

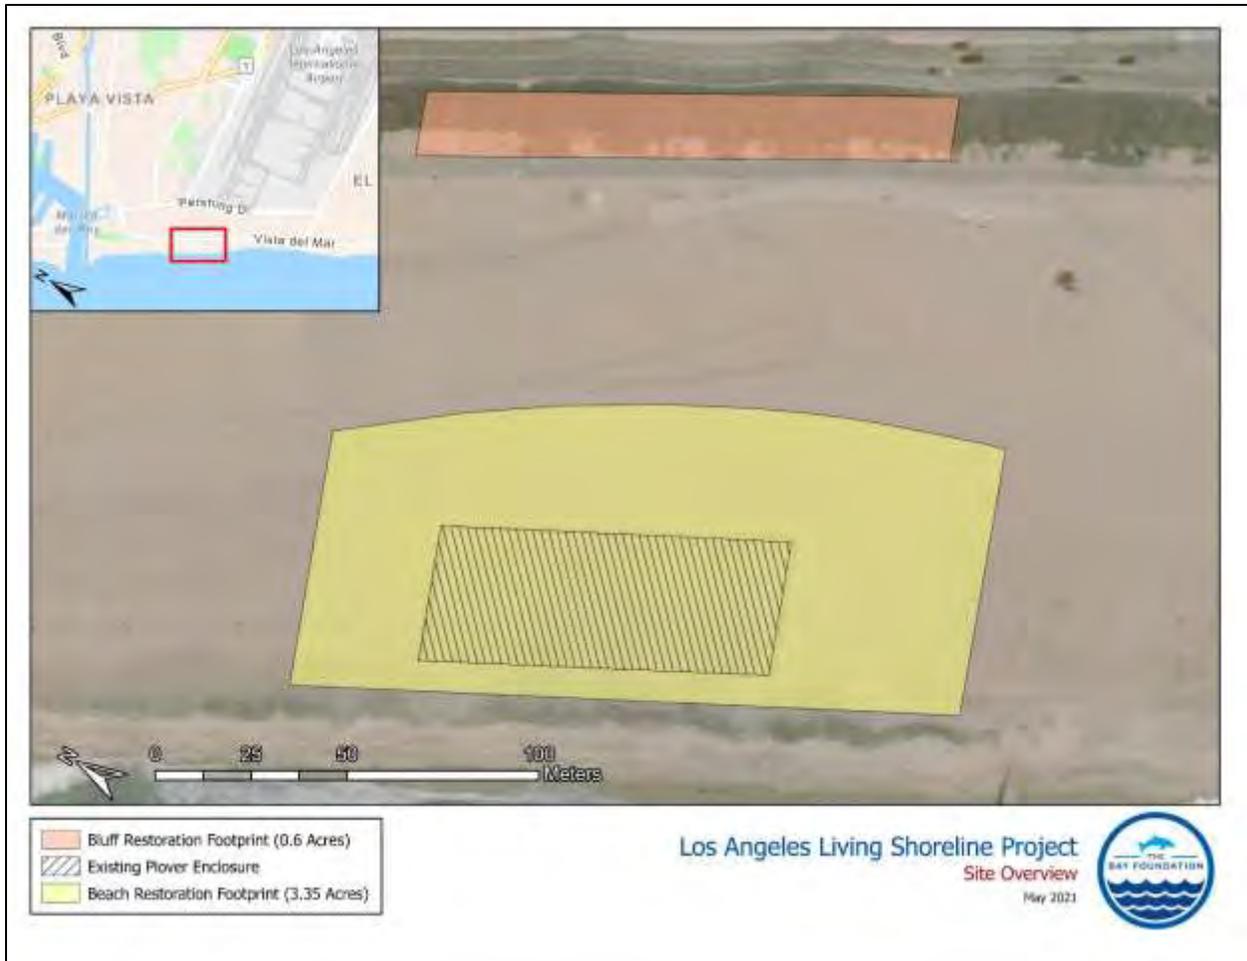
Figure 9. Overview map of the LA-LSP beach and bluff restoration area.

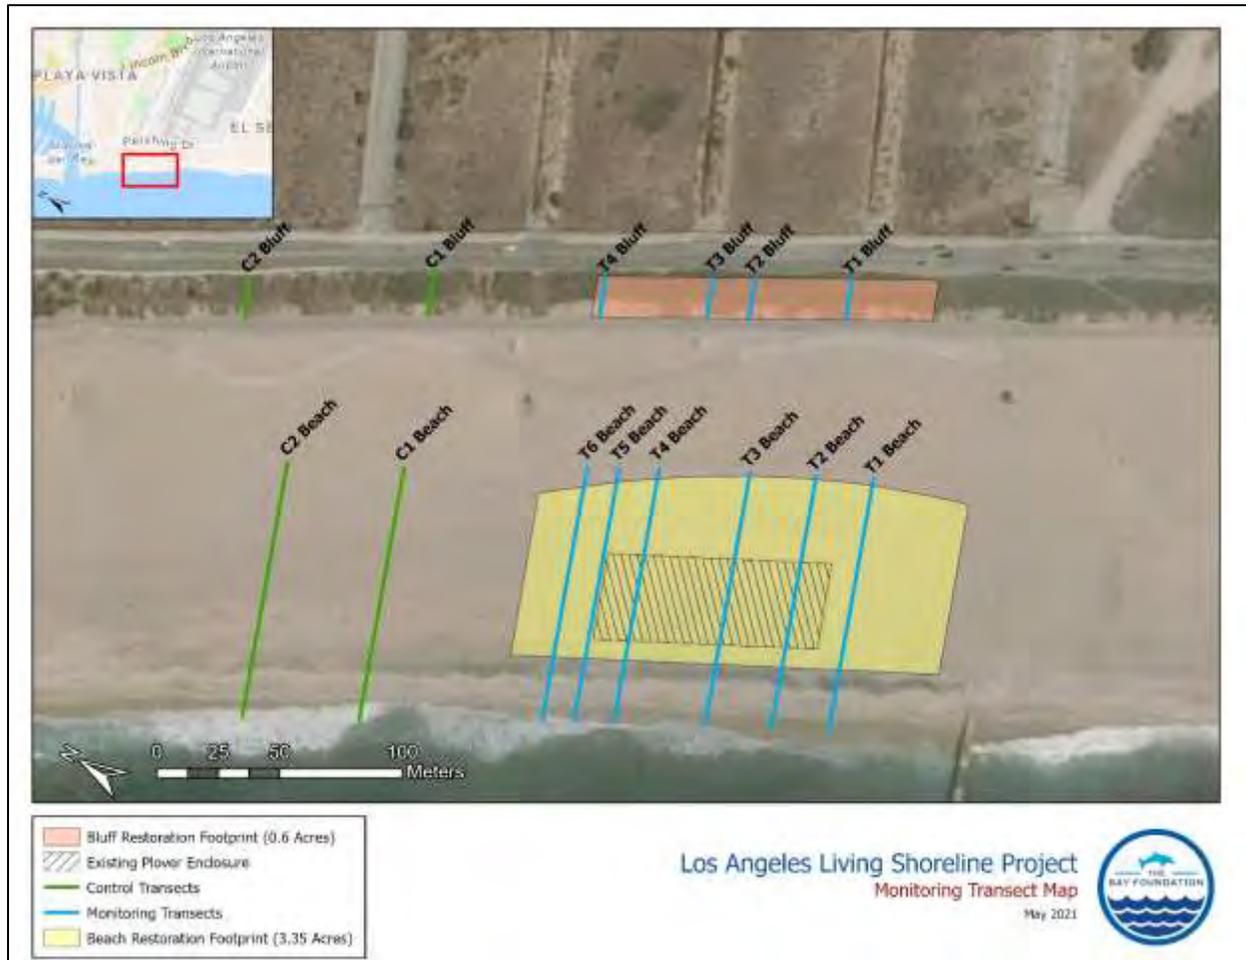
Figure 10. Map of beach and bluff restoration and control monitoring transects.

control transects were also established for each of the beach and bluff areas. Figure 10 displays a map of final restoration and control monitoring transects.

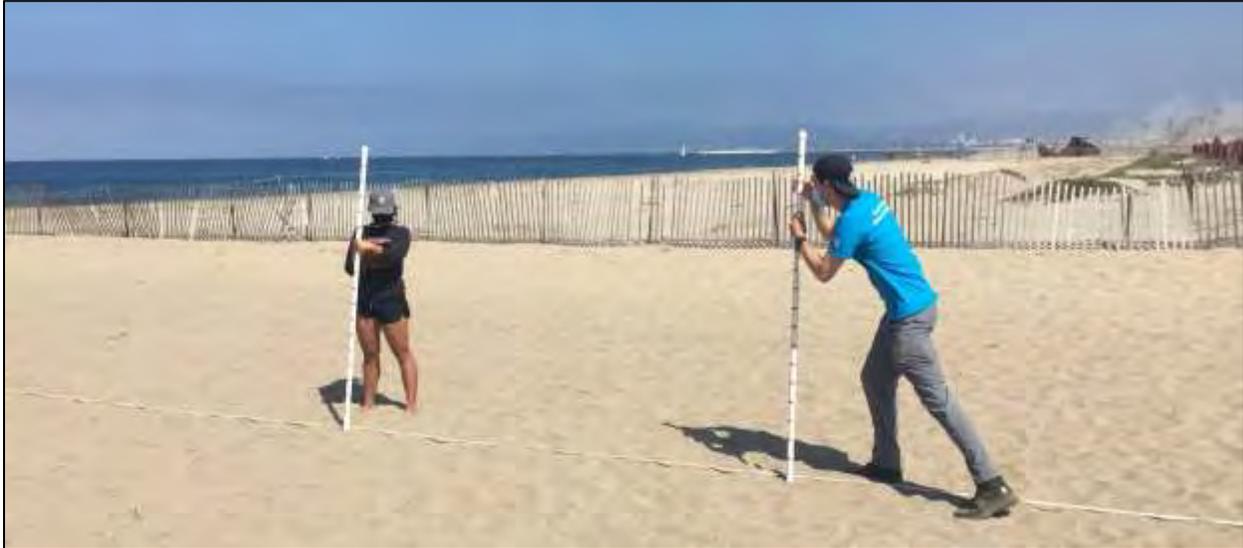
Figure 11. TBF conducting elevation profile survey on 15 July 2020.

2015c). Furthermore, elevation profiles were collected using a combination of elevation poles and a Trimble GPS (Figure 11). Methods are described in detail in Dugan et al. 2015 and below in the Physical Characteristics subsection of the Scientific Monitoring section. Western snowy plover data were collected by Tom Ryan, ornithologist, and LA Audubon Society through monthly roost surveys of historic roosting and nesting areas. Additional information on avifauna surveys can be found below in the Avifauna (and Pollinator Presence) subsection of the Scientific Monitoring section.

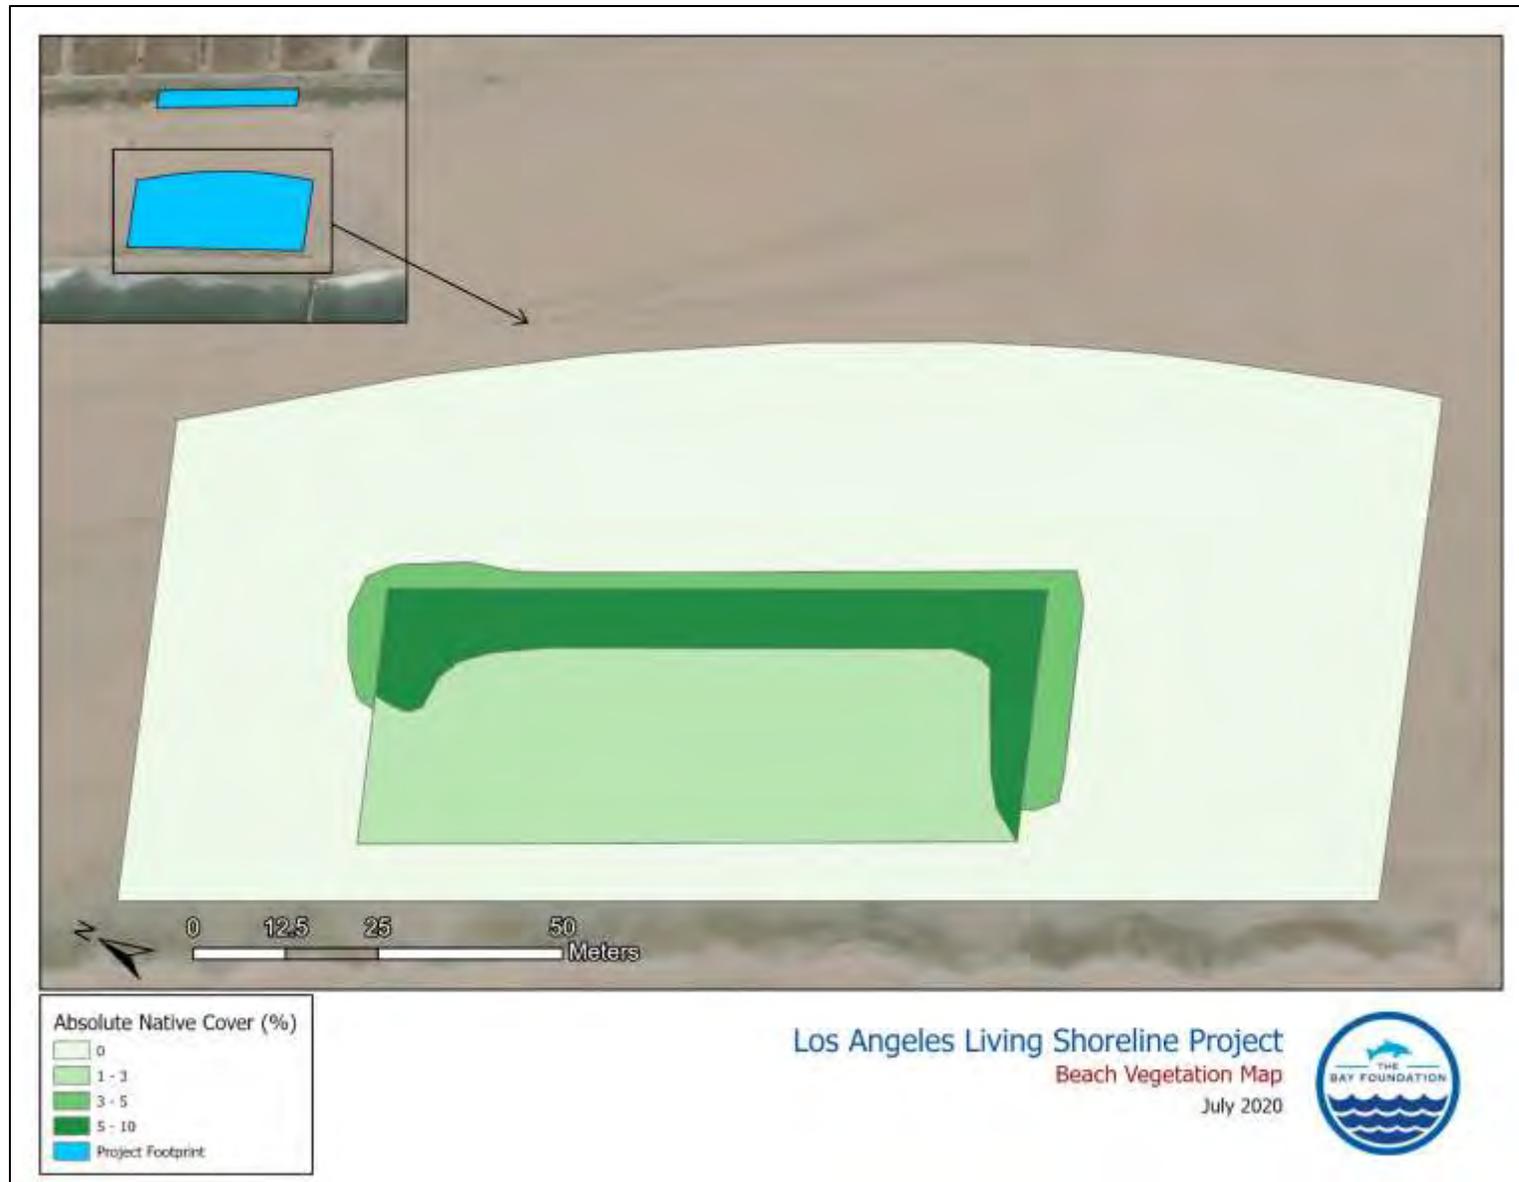
Figure 14. Beach vegetation mapping results displaying absolute native cover (July 2020).

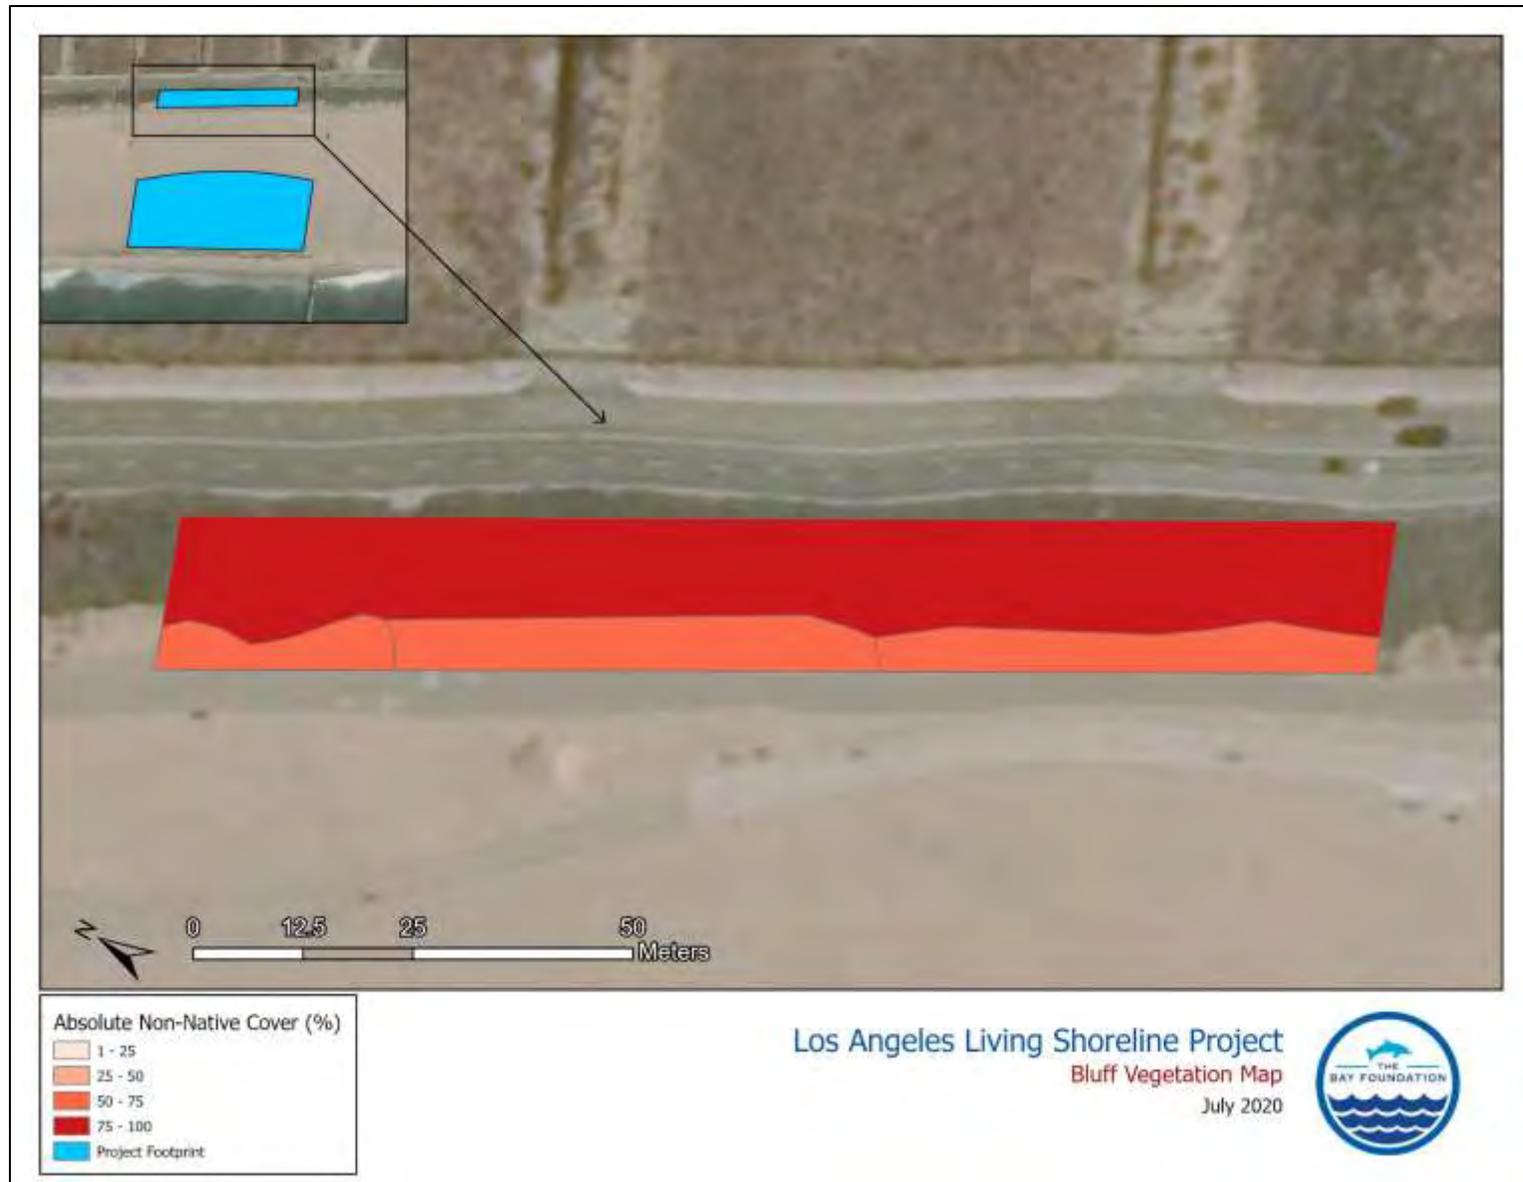
Figure 19. Bluff vegetation mapping results displaying absolute non-native cover.

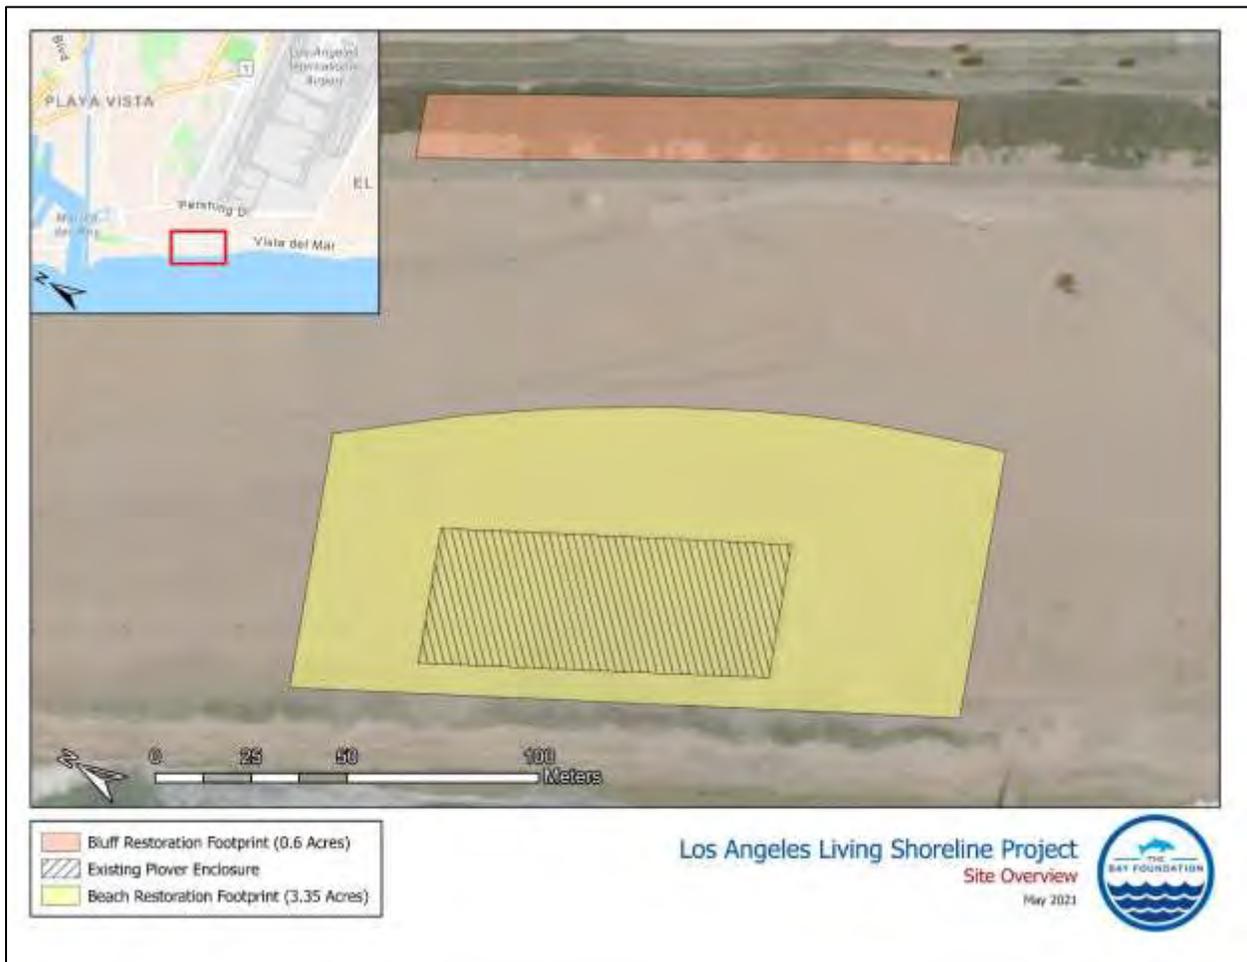
Figure 25. Overview map of the LA-LSP beach and bluff restoration area.

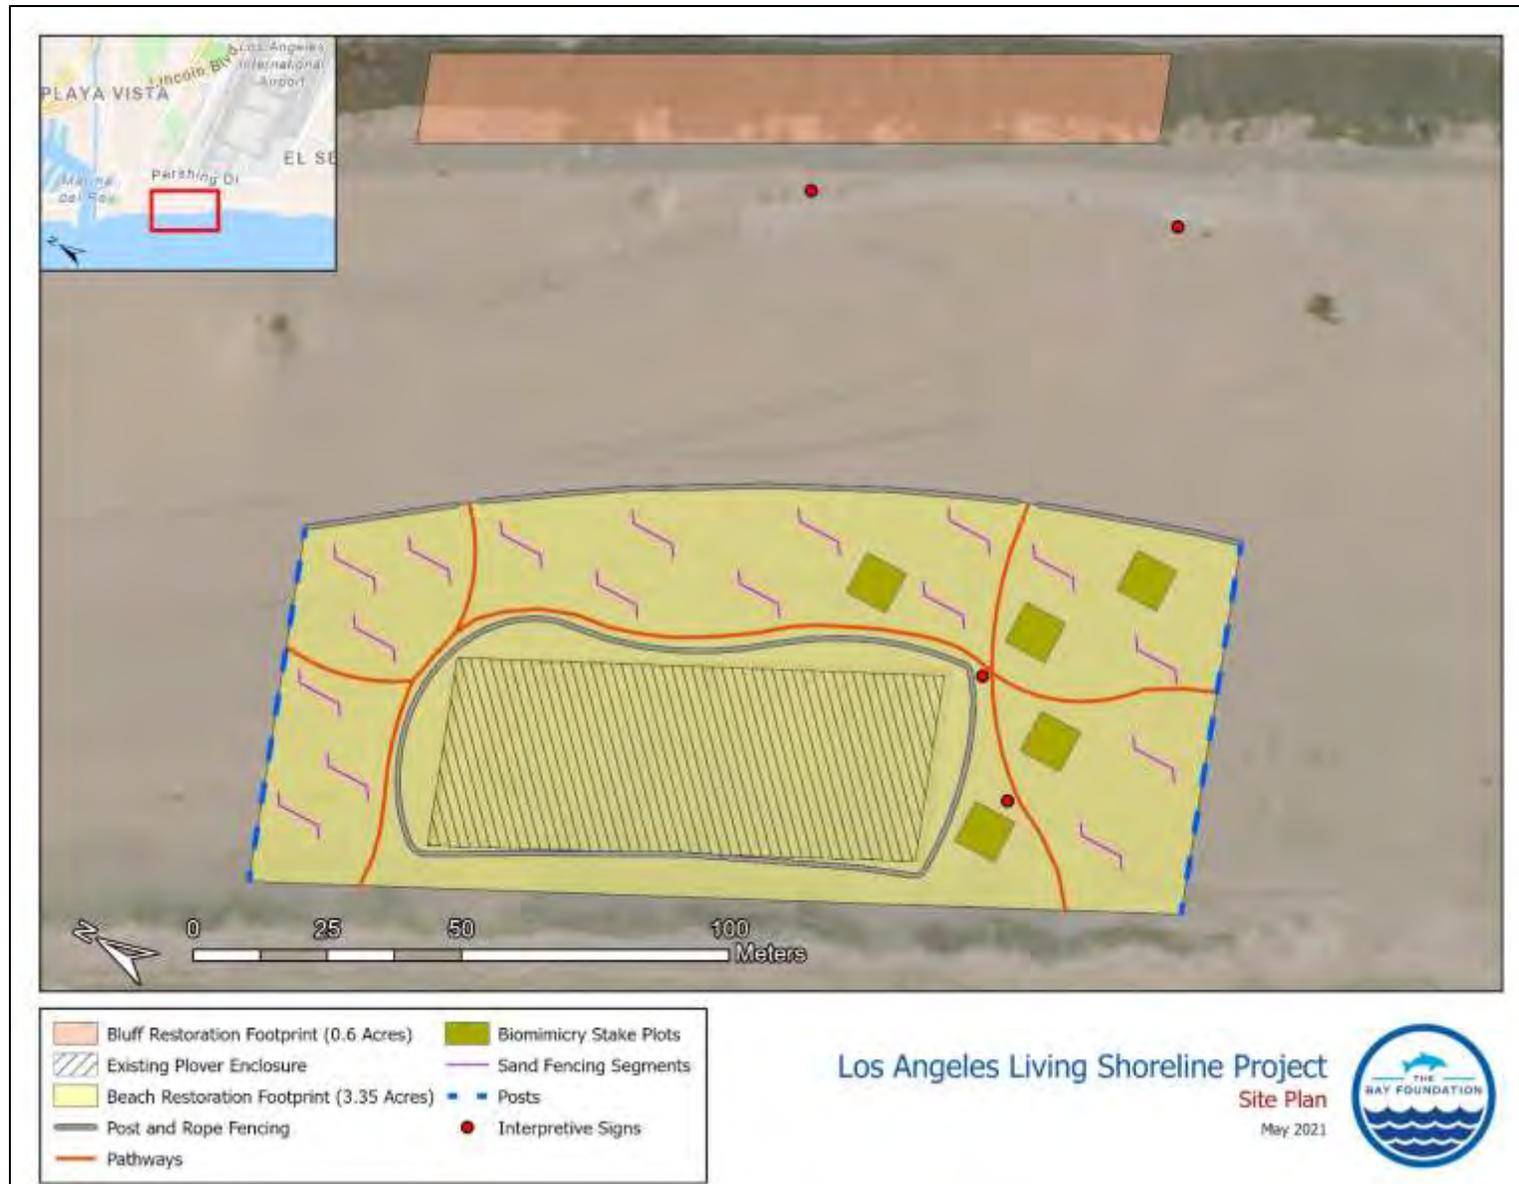
Figure 32. Project site plan including various restoration elements.

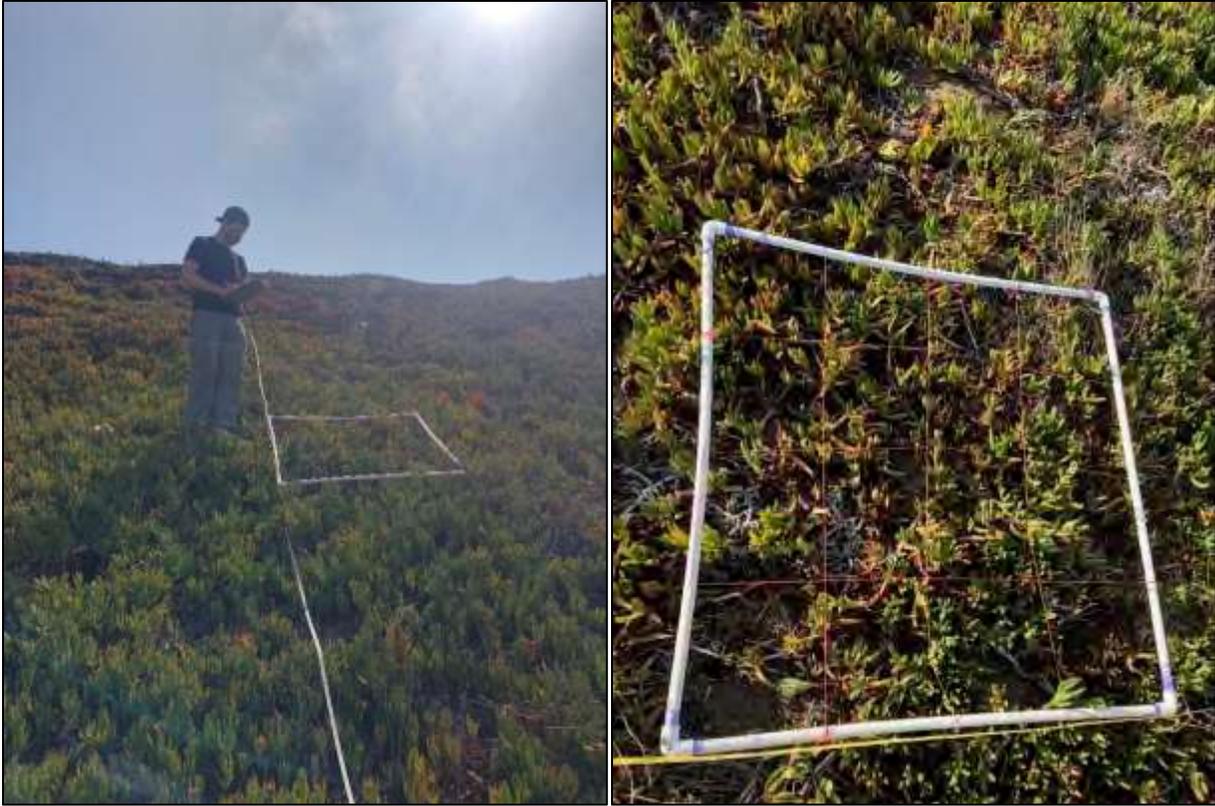
Figure 39. Baseline monitoring of vegetation cover within the bluff restoration area conducted in July 2020 using fixed quadrats along a transect.

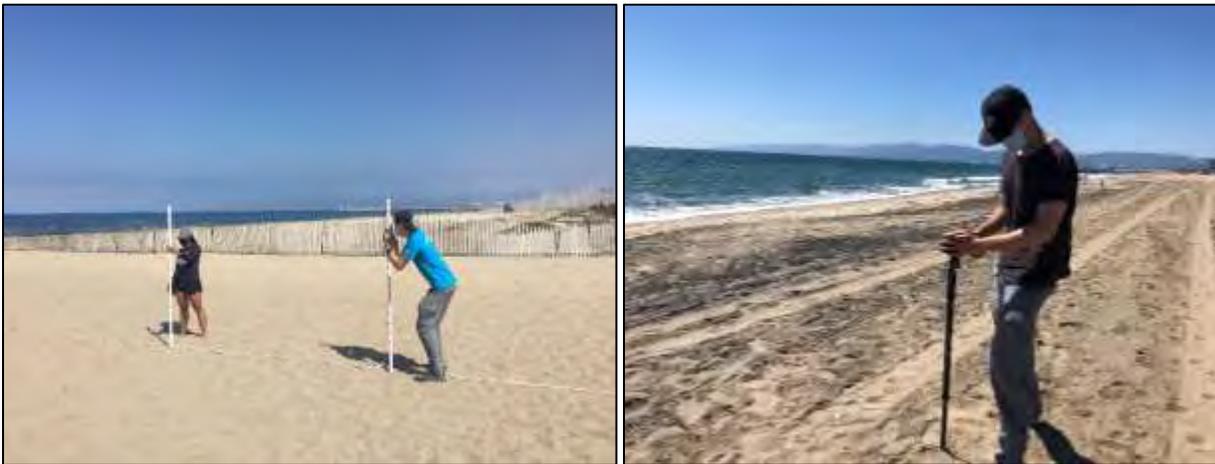
Figure 40. Baseline monitoring elevation profile surveys conducted along a beach transect in July 2020 using elevation poles (left) and GPS Trimble (right).
